Fire Investigation Summary

Fire Fighter Fatalities

**Marks, Mississippi
August 29, 1998**

**FIRE FIGHTER FATALITIES
MARKS, MISSISSIPPI
AUGUST 29, 1998**

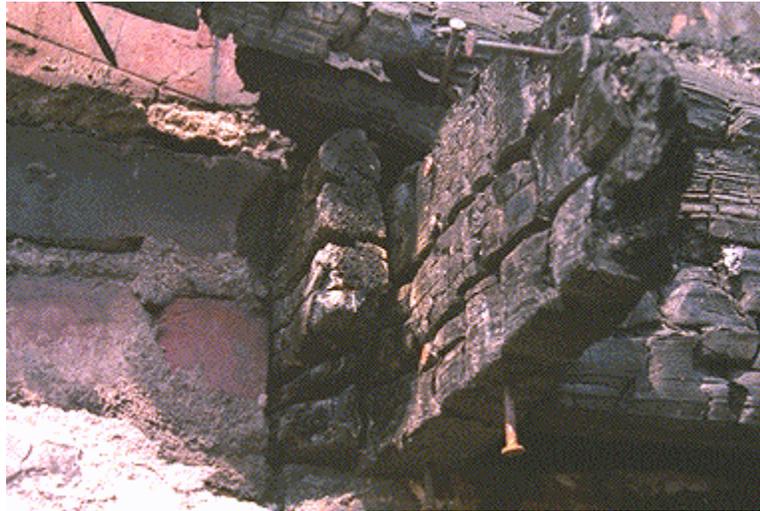
Photo No. 1: Roof joist ends at brick wall in florist shop (NFPA)

All of the firewalls had been breached in several locations. The walls between each establishment had been penetrated for the installation of vents and piping. As a result of the numerous penetrations, none of these walls could be considered true firewalls.

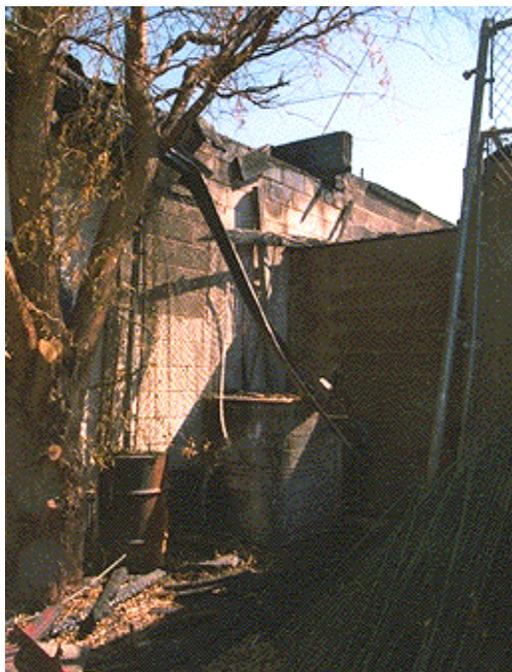
The fire fighter remaining on the roof then proceeded to walk over to the area of the florist shop. When he stepped from the roof of the restaurant onto the roof at the rear of the florist shop, at approximately 1:40 a.m., the weakened roof structure collapsed and he fell into the store, landing in the southeast storage room in the shop. No one on the fire ground witnessed his falling through the roof. His location was unknown to the others on the fireground.

Photo No. 3: Area of origin at rear of florist shop. Parapet in center of photo divides the florist shop and is near where the fire fighter fell through weakened roof structure. (NFPA)

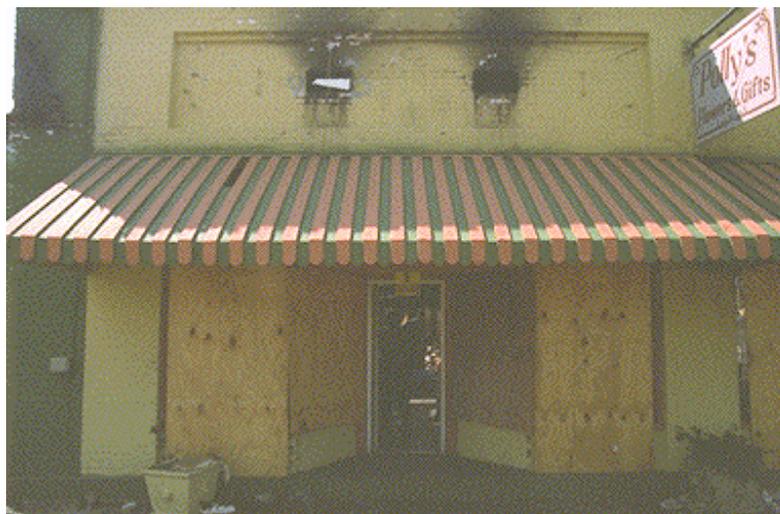
Photo No. 4: Front of florist shop. (Note attic vents above canopy) (NFPA)

The Lambert fire fighter entered the building again in search of the Marks fire fighter. The Lambert assistant chief donned breathing apparatus and followed the fire fighter into the florist shop. Photo No. 4 shows the front entrance of the florist shop.

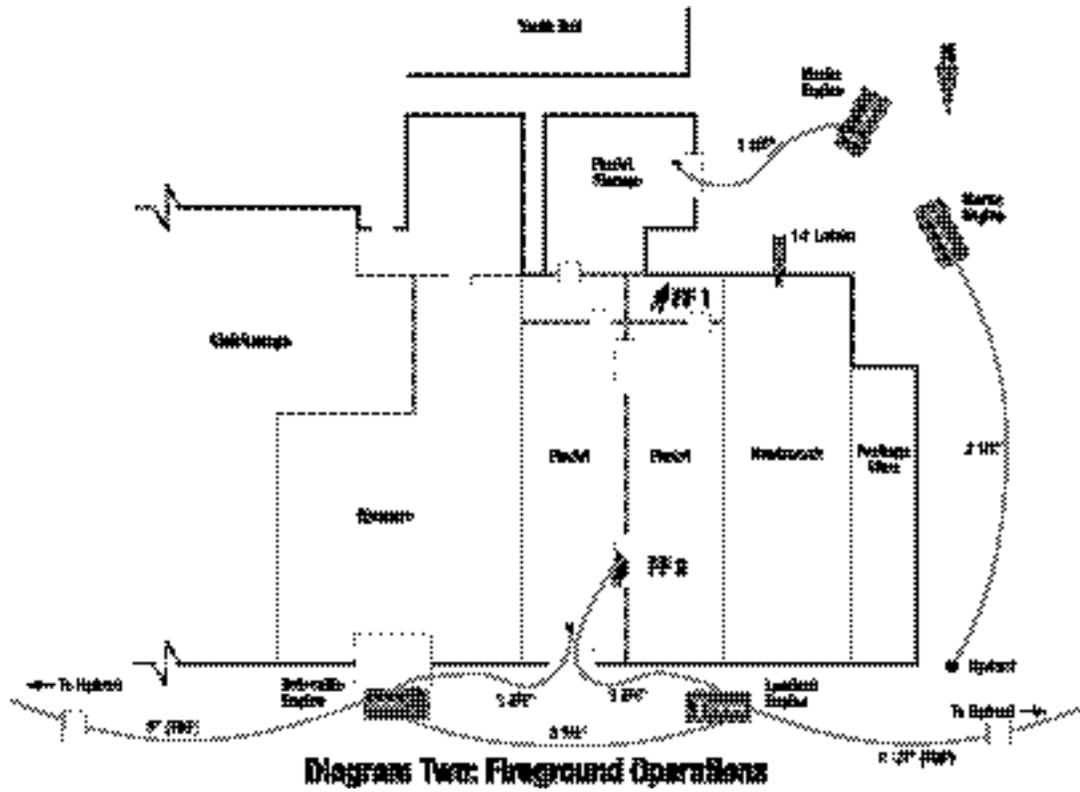
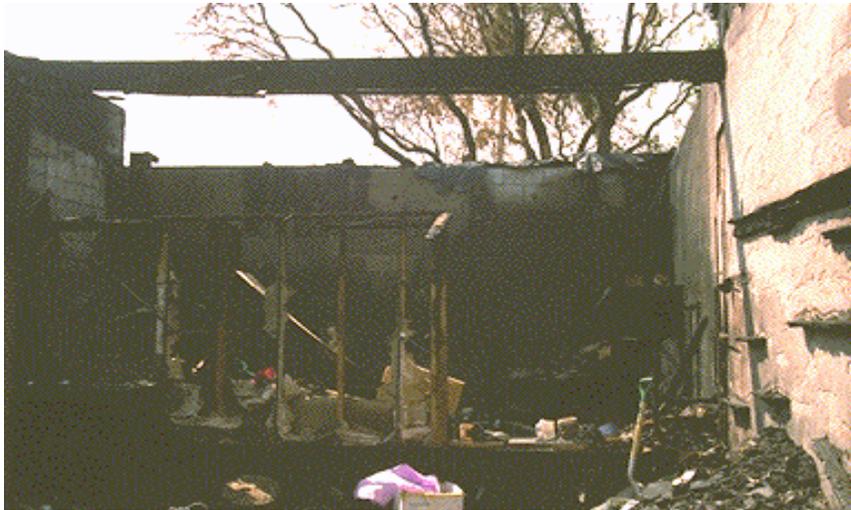
Photo No. 5: Rear storage room in florist shop where the body of second fire fighter was found. Photo taken facing rear wall (south). To the right is the party wall with the restaurant. (NFPA)

In the meantime, the search focused on his last known location, the rear of the florist shop. Efforts were made to extinguish the fire in this area to allow for a search of the back of the shop. Access was eventually made to the rear areas within the shop and a search was conducted in both storage rooms. The missing fire fighter's body was found in the southeast corner of the rear of the storage room at approximately 6:00 a.m. His body was located beneath debris from the roof structure and materials stored in the storage room. When the fire fighter was found, his air cylinder was empty. There are conflicting reports on the placement of his mask. The location of the body was documented and photos were taken prior to the removal of the body. Photo No. 5 shows the area where the fire fighter body was found.

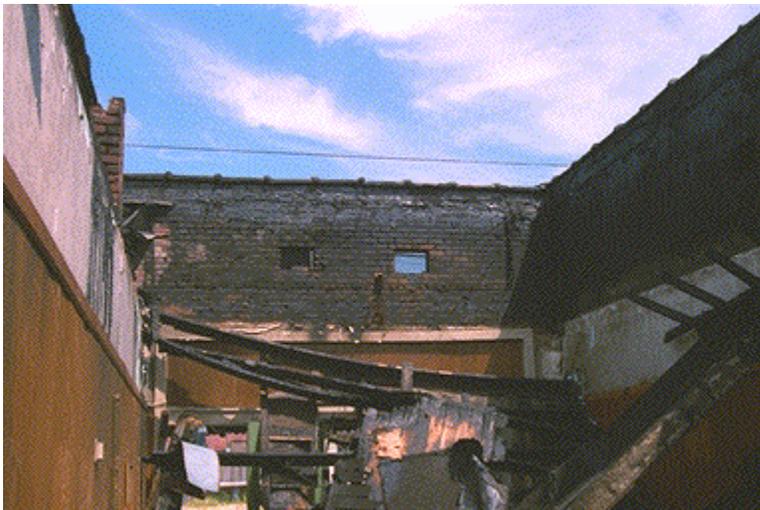
Once the fire entered the combustible attic space, it spread laterally east and west through the open attic space. The former brick firewalls, in place between each establishment, contained several penetrations. The fire then spread from the florist shop into the two adjoining spaces (dry cleaners and restaurant). The fire spread unchecked and out of sight for several minutes before smoke began to emanate from the attic ventilation grates on the north side of the building. This smoke was the first sign that the fire had entered the attic space and was spreading rapidly. The partially open attic space provided an avenue of fire travel from one end of the block to the other. (Photo No. 6 shows the attic space above the restaurant.)

Photo No. 6: View showing attic space at front (north) of restaurant. The blackened bricks indicate the attic area (NFPA)

With the fire spreading in the attic spaces, the roof support joists were weakened and eventually collapsed, first under the weight of the fire fighter on the roof and then under their own weight and the weight of the suspended ceiling installations in each

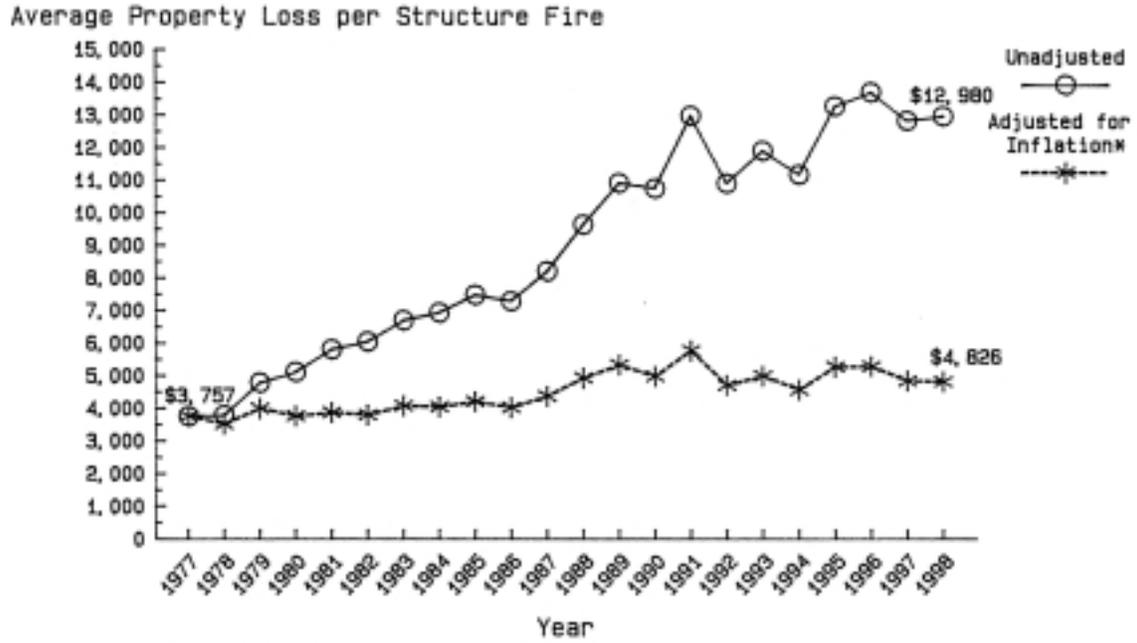
Figure 5
Average Property Loss per Structure Fire
in the United States (1977-98)

Fires in structures resulted in an estimated \$6,717,000,000 in property damage in 1998, a decrease of 5.2%. Average loss per structure fire was \$12,980, up a slight 1.1% from a year ago (see Figure 5). Over the 1977-98 period, the average loss per structure fire ranged from a low of \$3,757 in 1977 to a high of \$13,713 in 1996 for an increase of 265%. When property loss is adjusted for inflation, the increase in the average loss per structure fire for 1977 and 1996 decreases to 42%.
