Quantifying the Impact of Portable Fire Extinguisher Agents on Cultural Resource Materials: Fire and Non-Fire Exposure Tests

Fire Suppression and Detection Research and Applications – A Technical Working Conference (SUPDET 2016), March 1 – March 4, 2015, San Antonio, TX

Matthew E. Benfer, Joseph L. Scheffey, and Eric W. Forssell,
JENSEN HUGHES Inc.
3610 Commerce Dr., Ste. 816, Baltimore, MD 21227, 410-737-8677

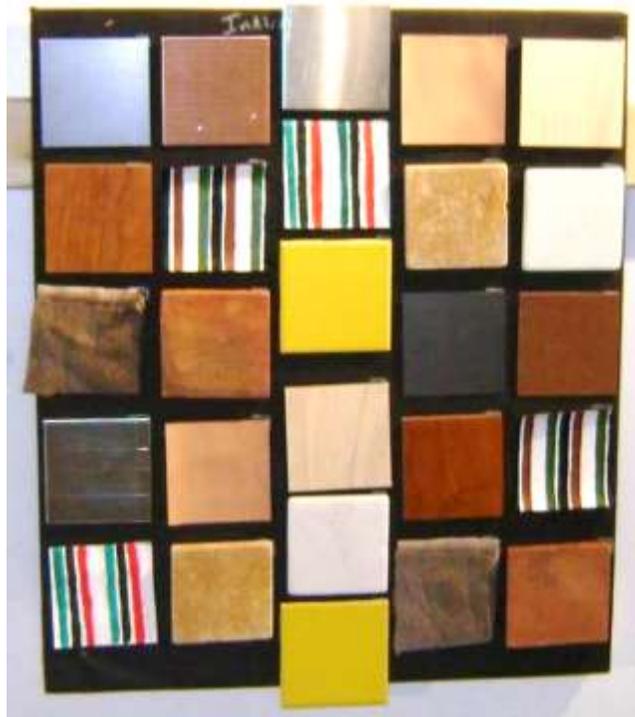
Figure 1 – Typical sample array for exposure tests.

The sample materials were mounted on plywood sample arrays using Velcro®. One sample of each material was located near the center of the sample array and one was located near the perimeter of the sample array. The test sample array included 26 samples (2 x 13 materials), with the center column containing six samples with reduced vertical spacing between samples. The total exposed area was approximately 56 cm (22 in.) wide by 67 cm (26.5 in.) tall. A photograph of a typical sample array is shown in Figure 1. The samples were placed in the same locations for each test.

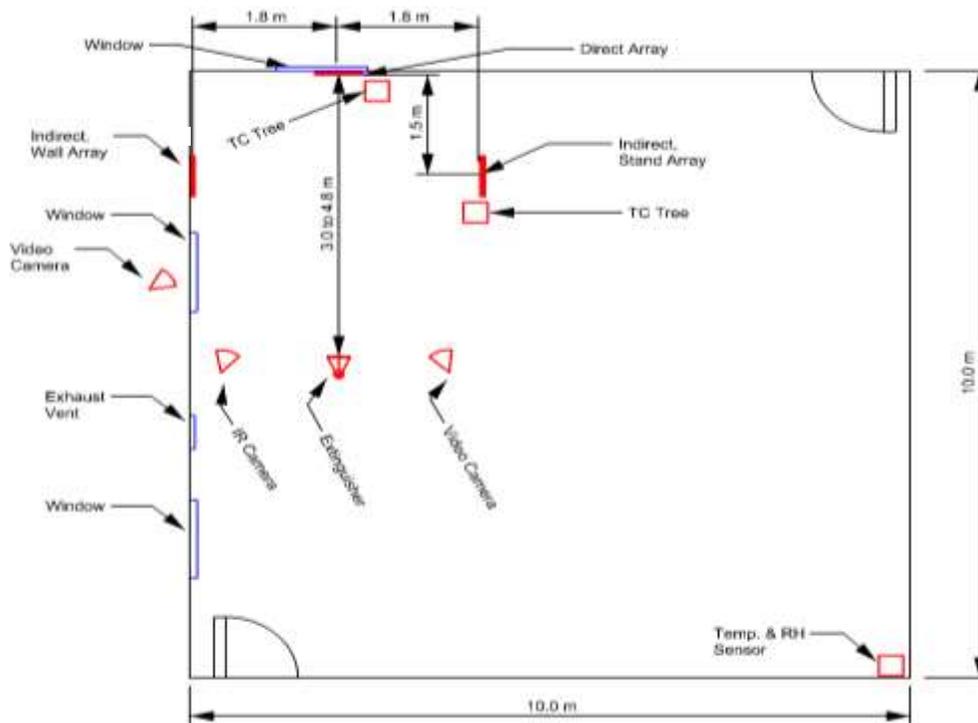
Figure 2 – Non-fire exposure apparatus, plan view.

The instrumentation for the fire and non-fire tests was largely the same; Figure 2 is a schematic of the test enclosure with instrumentation for the non-fire tests. Figure 3 is a photograph of the test setup for the fire tests; the test setup for the non-fire tests was the same, except with the wood crib removed. The instrumentation employed during these tests included a scale to measure the deposition on the exposed objects. The scale was able to measure mass with a resolution of 0.001 g (2.2×10^{-6} lb). A scale with a larger resolution (0.1 g [0.0002 lb]) was used for samples weighing over 300 g (0.66 lb).

In the test enclosure, the temperature and relative humidity were monitored. Temperatures were recorded at two locations using vertical trees of five, evenly spaced type-K thermocouples at heights of 0.3, 0.9, 1.5, 2.1, and 2.7 m (1, 3, 5, 7, and 9 ft) above the floor. One was installed 0.45 m (1.5 ft) from the center of the indirectly exposed object array and 2.5 cm (1.0 in.) in front of the indirect array. The second was installed 0.45 m (1.5 ft) from the center of the directly-exposed object array and 2.5 cm (1.0 in.) in front of the direct array. In addition, a thermocouple was installed in the center of the directly-exposed object array so that the thermocouple bead was flush with the sample surface. This thermocouple was installed from behind the sample array.

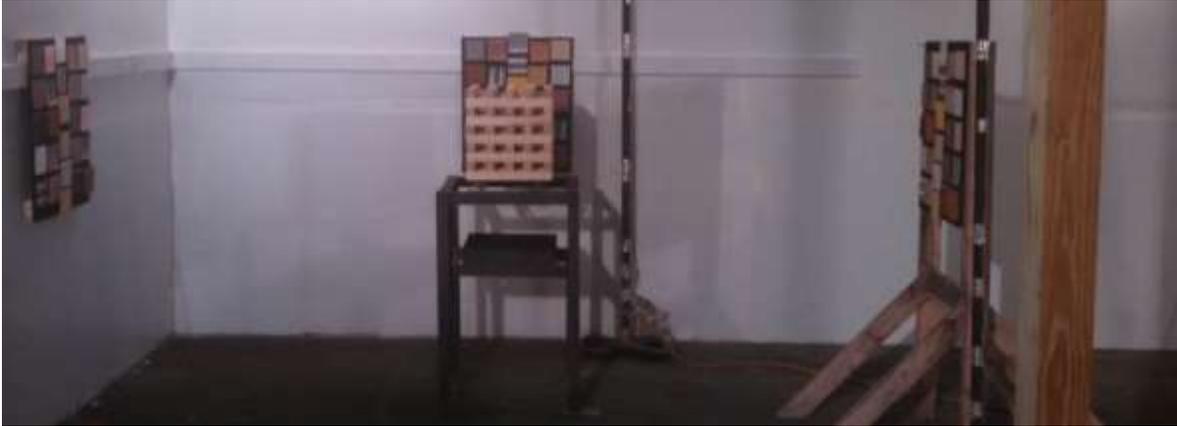
Figure 3 – Fire exposure test setup.

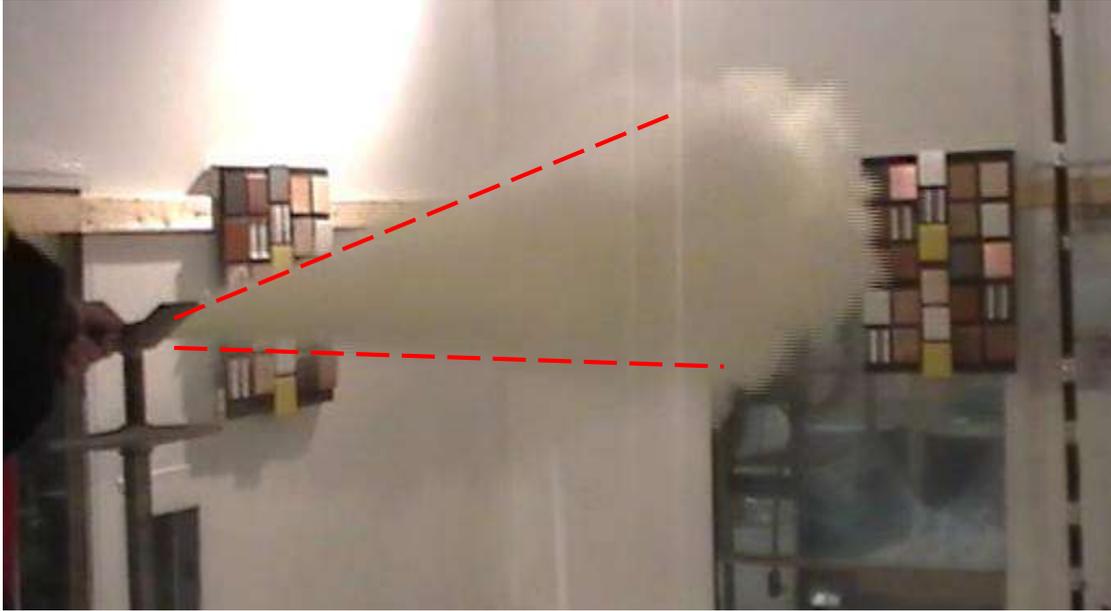
Figure 4 – Typical ABC dry chemical extinguisher spray pattern.

The spray patterns for the extinguishers were significantly different from each other. The ABC dry chemical extinguisher spray was a narrow stream as shown in Figure 4. After discharge, the agent rapidly formed a cloud as it impacted the enclosure wall. This cloud quickly filled and obscured the interior of the enclosure, reducing enclosure visibility. The firefighter had limited visibility. After the end of the 5 minute “soak period”, much of the agent had settled which allowed greater visibility. The ABC dry chemical spray pattern was consistent between Tests 1A and 5A. During Test 5A, the water mist extinguisher discharge tended to stir up the ABC dry chemical that had been discharged into the enclosure further reducing visibility.

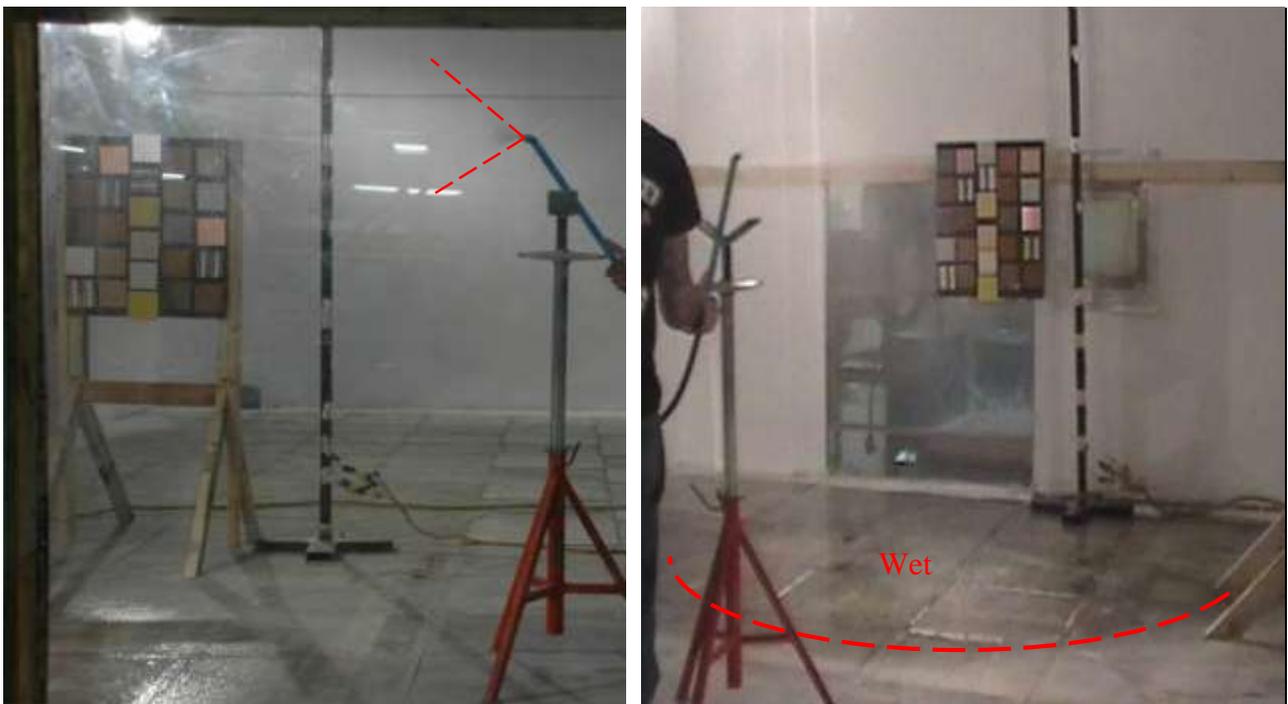
Figure 5 – Typical water mist extinguisher spray pattern (left) and water deposited on the floor (right).

The water mist extinguisher produced a wide spray compared to the other extinguishers as shown in Figure 5 (left). The water mist spray was difficult to capture with photos or video footage; an outline of the spray pattern is shown for reference in Figure 5 (left). The droplets from the water mist extinguisher were relatively large compared to a high-pressure building water mist system. A significant amount of water was deposited on the floor of the enclosure in front of the extinguisher nozzle as outlined in Figure 5 (right). This was consistent between Tests 2A and 5A.

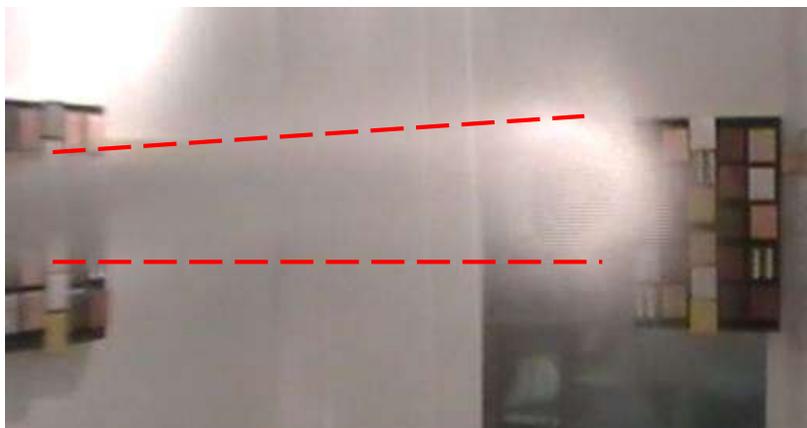
Figure 6 – Typical Halotron I extinguisher spray pattern.

The Halotron I extinguisher produced a narrow gas stream with a minimal amount of liquid agent present in the stream (see Figure 6). By the time the stream reached the direct sample array, most of the liquid had evaporated. The liquid agent quickly evaporated and the gaseous agent cloud quickly dissipated.

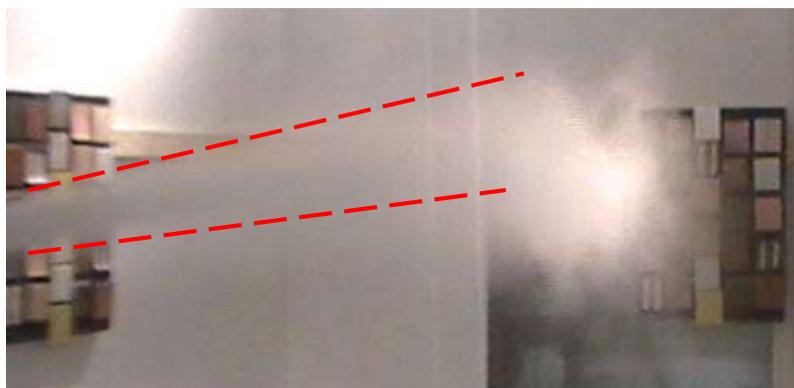
Figure 7 – Typical FE-36 extinguisher spray pattern.

The FE-36 extinguisher produced more of a narrow stream than the Halotron I extinguisher (see Figure 7). The agent stream was mostly liquid as it left the extinguisher; a notable amount of liquid agent remained as the stream impacted the direct array. The liquid agent quickly evaporated and the gaseous agent cloud quickly dissipated.

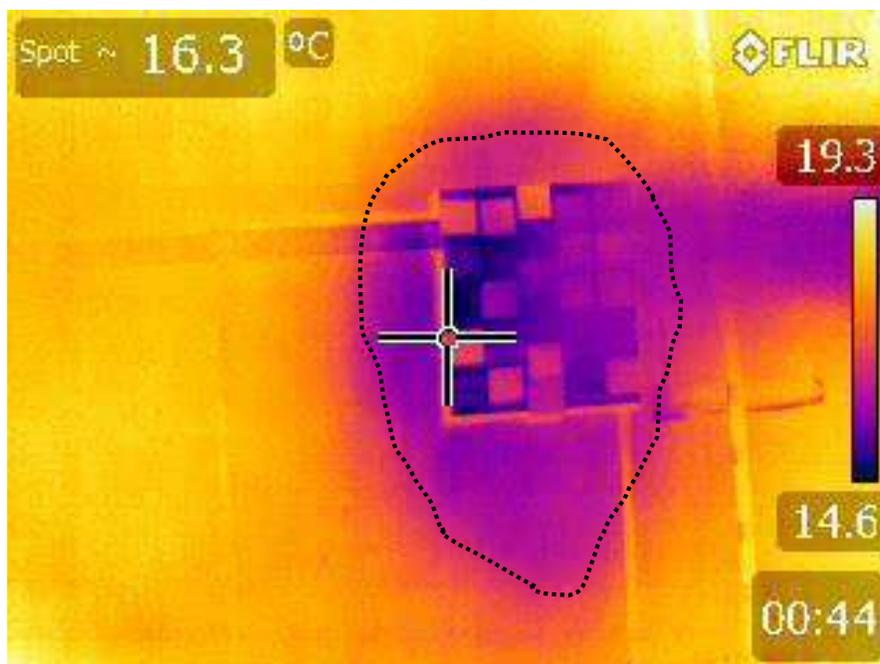
Figure 8 – Typical infrared image of Halotron I extinguisher coverage.

The infrared footage of the Halotron I discharge (Test 3A) showed the only well-defined extinguisher spray pattern and agent impact area out of all of the tests. As shown in Figure 16, the Halotron I discharge is a narrow stream; this is confirmed by the visual image of the spray pattern shown in Figure 6. The extinguisher discharge covered the entire direct array with some overspray to the enclosure wall (based on temperature drop circled in Figure 8). The overspray area is only slightly larger than the size of the direct sample array.

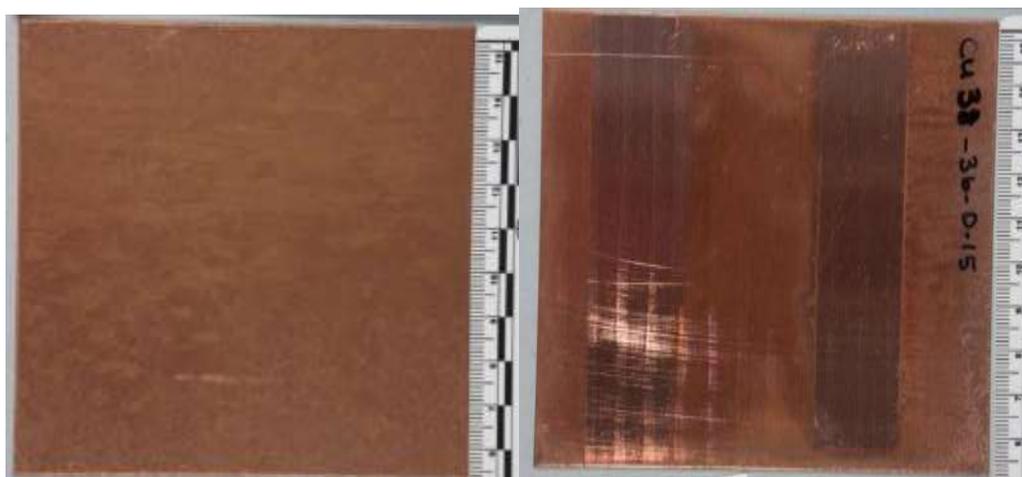
Figure 9 – Typical front (left) and back (right) of copper sample exposed to fire and Halotron I.

Halotron I had two effects that were unexpected. On the acrylic paint on canvas samples, the green pigment was lost from the canvas. This was only found on one sample and it is necessary to explore further whether the result is due to a flaw in the sample preparation or potentially a result of the cold temperatures causing damage to the sample. Of more concern was the degree of corrosion and tarnish seen on all the metal samples involved in the fire tests with Halotron I. In Figure 9, the front (right) and back (left) of a copper sample are shown. The brighter patches on the bottom image are where the Velcro masked the metal during exposure; the other areas show the notable tarnish of the copper.

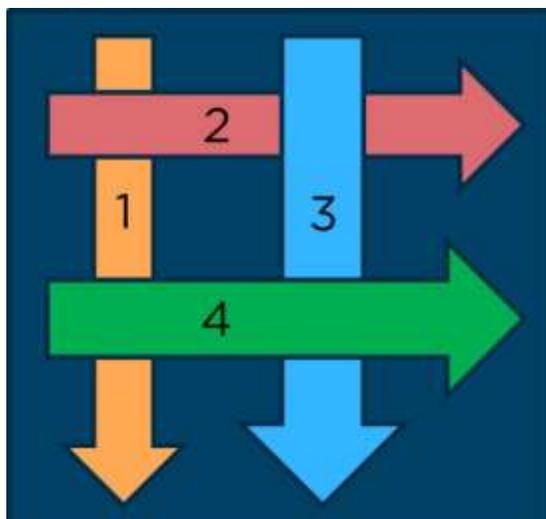
Figure 10 – Schematic of cleaning method.

Each sample was divided into 4 (2 by 2 inch) quadrants. Each quadrant was cleaned by a different method. All cleaning methods were chosen because they are commonly referenced in conservation literature for cleaning items that have been exposed to soot/and or fire. The four cleaning methods included swabbing with deionized water, rubbing with a soot eraser, brushing, and vacuuming. A standardized cleaning approach was used to ensure repeatability. For each cleaning method, the device was used in the sequence illustrated in Figure 10.
