SUPPLEMENT 3

Microbiologically Influenced Corrosion in Fire Sprinkler Systems

Editor's Note: Supplement 3 has been included to provide the user with background information related to microbiologically influenced corrosion or MIC. While MIC has been in existence for some time, it has recently become a maintenance problem, through recognition of the source of corrosion, for those involved in the maintenance of fire protection systems. The supplement discusses the microbial corrosion process and recognition and treatment of MIC for fire protection systems.

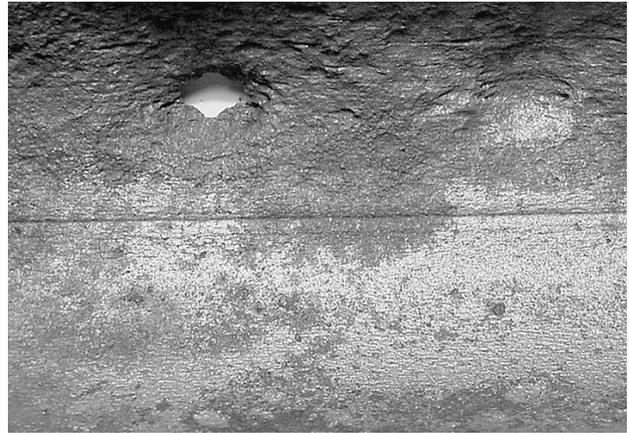
EXHIBIT S3.1 Interior Pinhole Leak.

In contrast to general, or uniform, corrosion, MIC is a form of localized corrosion. Material is lost at discrete points instead of universally across an entire surface. There are several types of localized corrosion, including pitting, crevice, cratering, and filiform. (See Exhibit S3.1.)

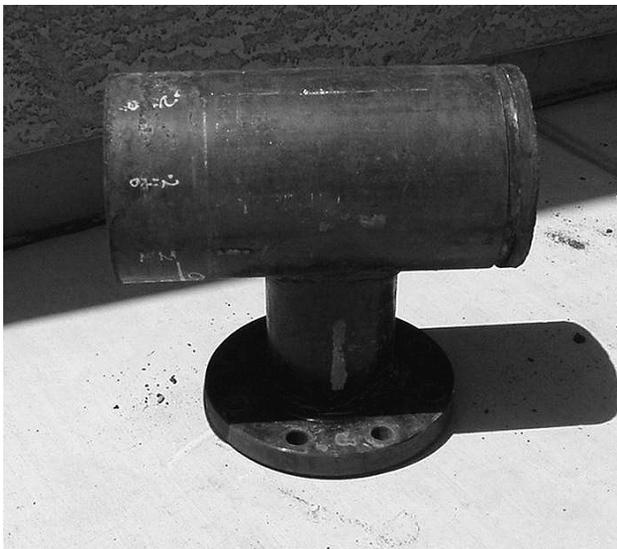
EXHIBIT S3.2 Exterior View of Pipe with No Signs of Internal Corrosion.

While this formula is not intended to be used for non-uniform pipe surfaces, it is clear that random pockets of biological growth have the potential to affect performance. This is especially true if a sprinkler system has a minimum design buffer, which is regularly the case. (See Exhibit S3.2 and Exhibit S3.3.)

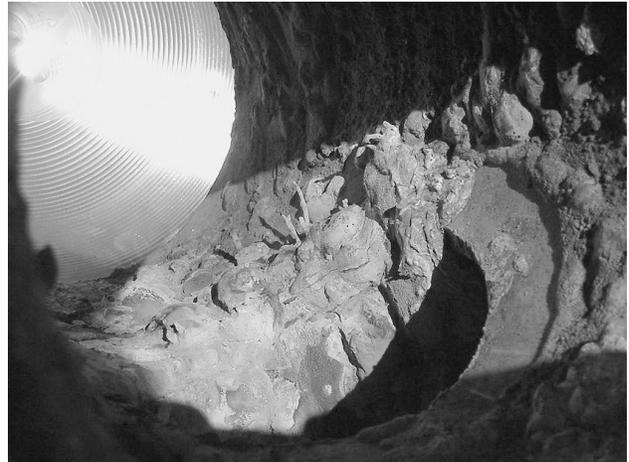
EXHIBIT S3.3 Interior View of Pipe Shown in Exhibit S3.2 with Approximate 65 percent Obstruction to 6 in. Tee Connection.

The second and more worrisome effect is the failure of a system to operate as designed to achieve fire control. This failure not only affects property loss but also could threaten lives. Several systems with MIC have been found with obstructed sprinkler drops, the result of debris generated as a by-product of microbial activity (called biofilm or biosludge). Many in the industry have found systems with feed mains over 60 percent obstructed from biological growth. [5,6] An analysis of corrosion buildup indicates that thousands of pounds of debris can accumulate in medium-sized piping. [7] This buildup of debris presents an obvious hydraulic concern, as many affected sprinkler systems today will not provide fire control as the required discharge criteria, in terms of flow and pressure, are not available due to obstruction and associated frictional pressure loss.

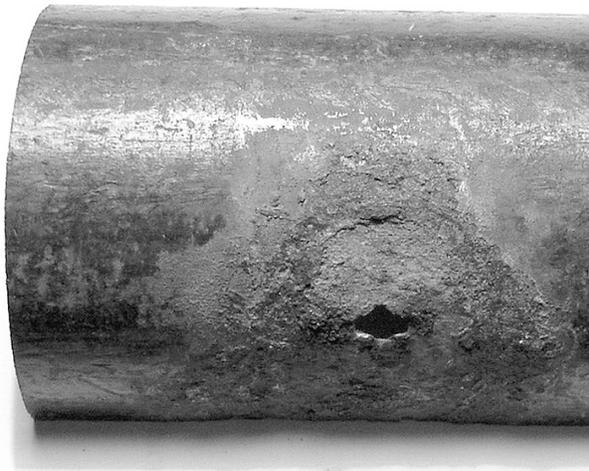
EXHIBIT S3.4 Exterior Pinhole.

In one known case, MIC-related leaks resulted in the shutdown of an aerospace manufacturer’s global computing center. [4] A pinhole leak developed in a wet pipe

sprinkler branch line located over the mainframe equipment of the computing center. Water from the leak not only damaged computing equipment but also resulted in over 5000 hours of lost operations time. Property damage from similar leaks at other sites has also been documented in the millions of dollars. [4,5]

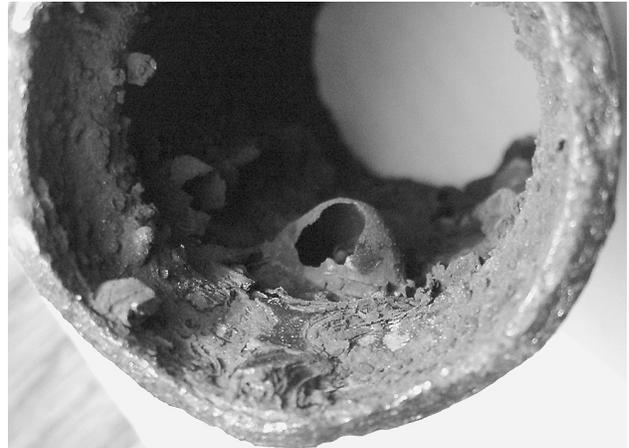
EXHIBIT S3.5 Interior Tubercle.

3. Tubercles and associated biofilms create microenvironments on the metallic material surface (under the tubercles). Tubercles are hard protective shells formed by biological activity. Tubercles typically have an open interior fluid cavity over the corrosion floor area with an approximate pH of 3 to 4. (See Exhibit S3.5.)
