# **Selected Published Incidents Involving Cold Storage Facilities**

**One-Stop Data Shop  
Fire Analysis and Research Division  
National Fire Protection Association**

**March 2011**

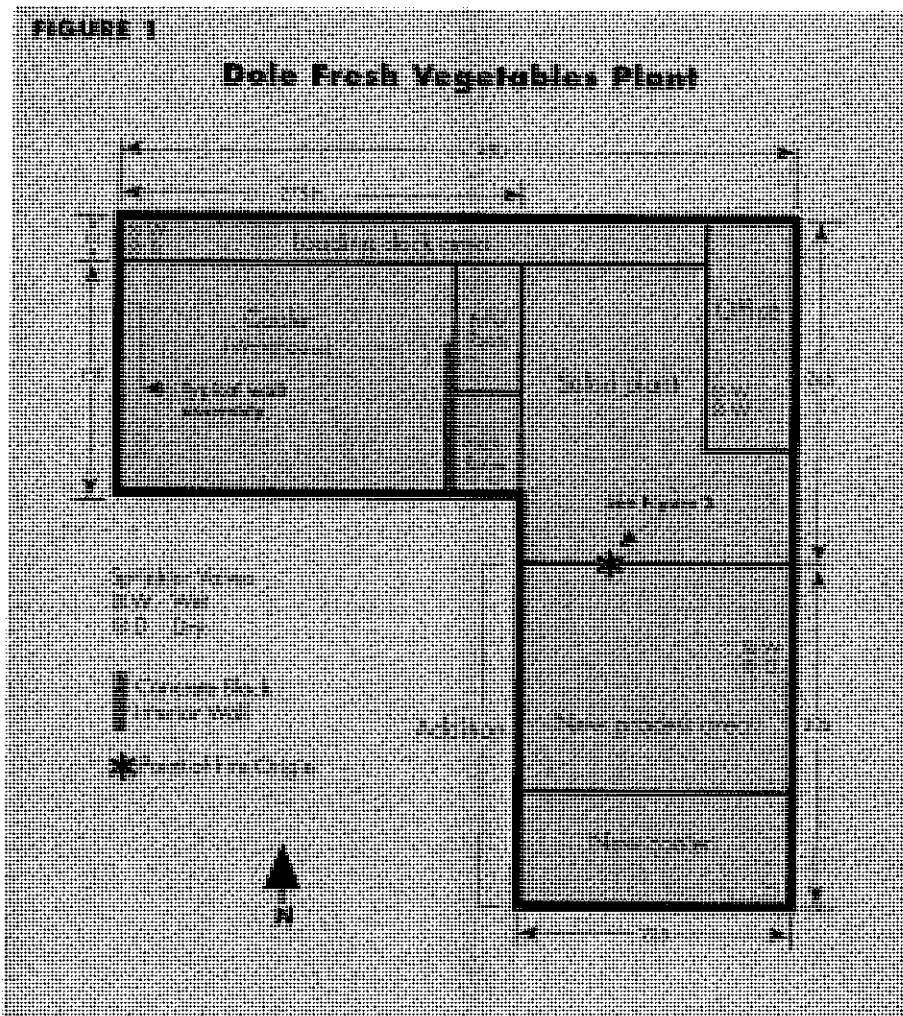
FIG. 1. The National Fire Protection Assoc., Inc.

The cross-sectional detail for walls varied at different locations in the building. For example, the wall between the salad plant and the addition reportedly had horizontal barriers to prevent vertical fire spread installed at each girt level (see Figure 2).<sup>1,2</sup> The barriers were constructed by extending gypsum wallboard between horizontal 2-by-4-inch wall-framing members and the metal wall girts. None of the facility's walls had vertical barriers to prevent horizontal fire spread in the walls.

The construction of the cooler's interior walls was similar to the wall construction in the salad plant and the addition. As in most of the other walls, the wood framing of the cooler walls was several inches from the foam insulation and was covered with plywood which was covered with fiberglass. However, the plywood and fiberglass in the cooler covered only the bottom half of the walls; moisture-resistant gypsum wallboard covered the top half of most of the walls. The horizontal barriers in these walls were installed at alternating girt levels (see Figure 2).

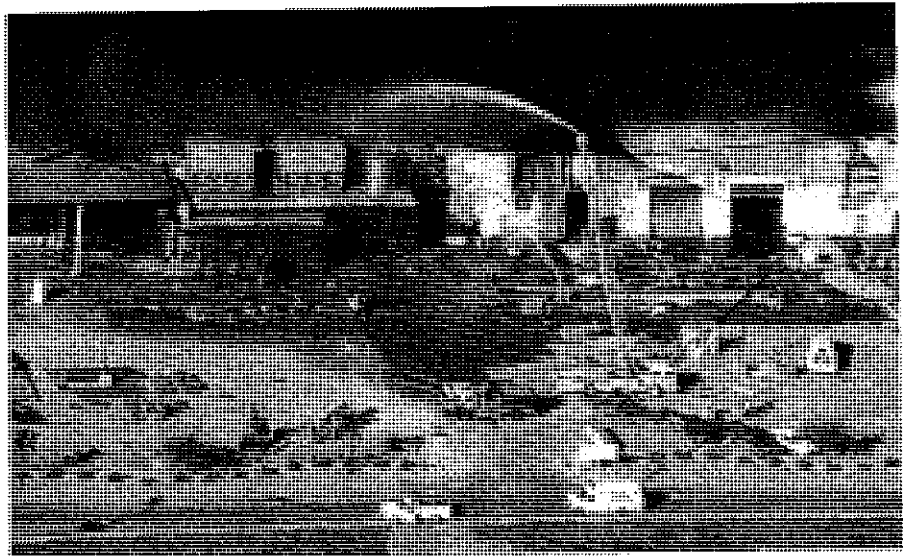
**Aerial stream applies water to smoking roof of the Dole plant in suppression activities that lasted almost 24 hours.**

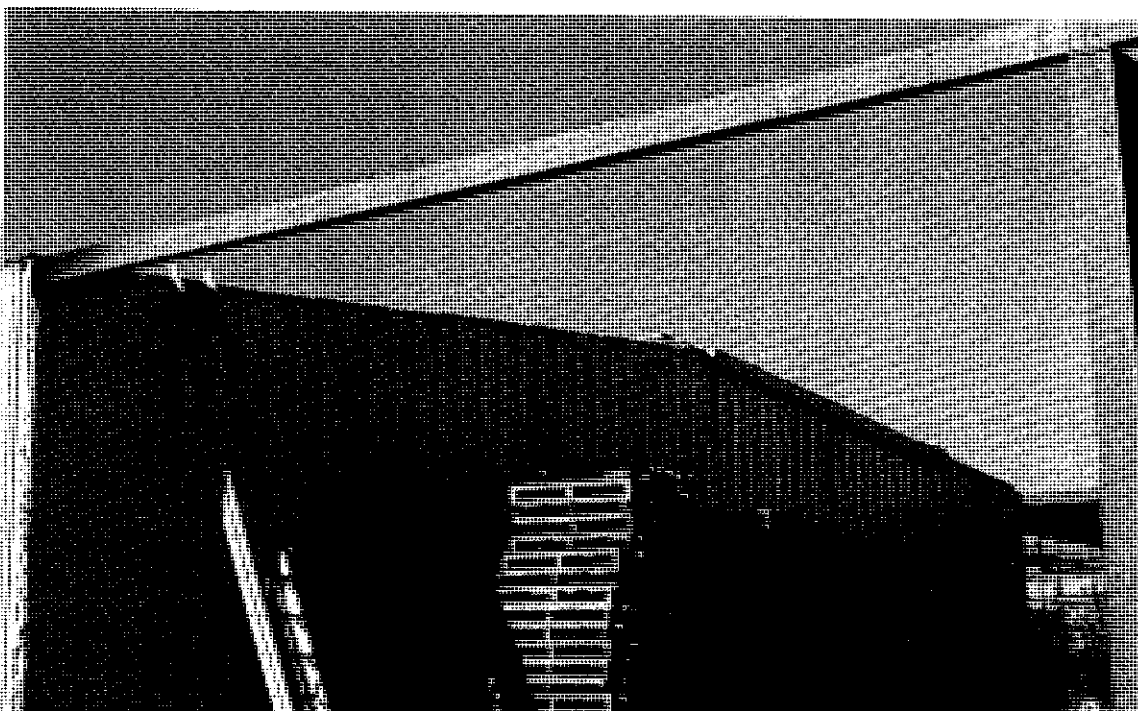
The south end of the warehouse. Fire started when a cutting torch was used on the upper right-hand corner above scaffolding.

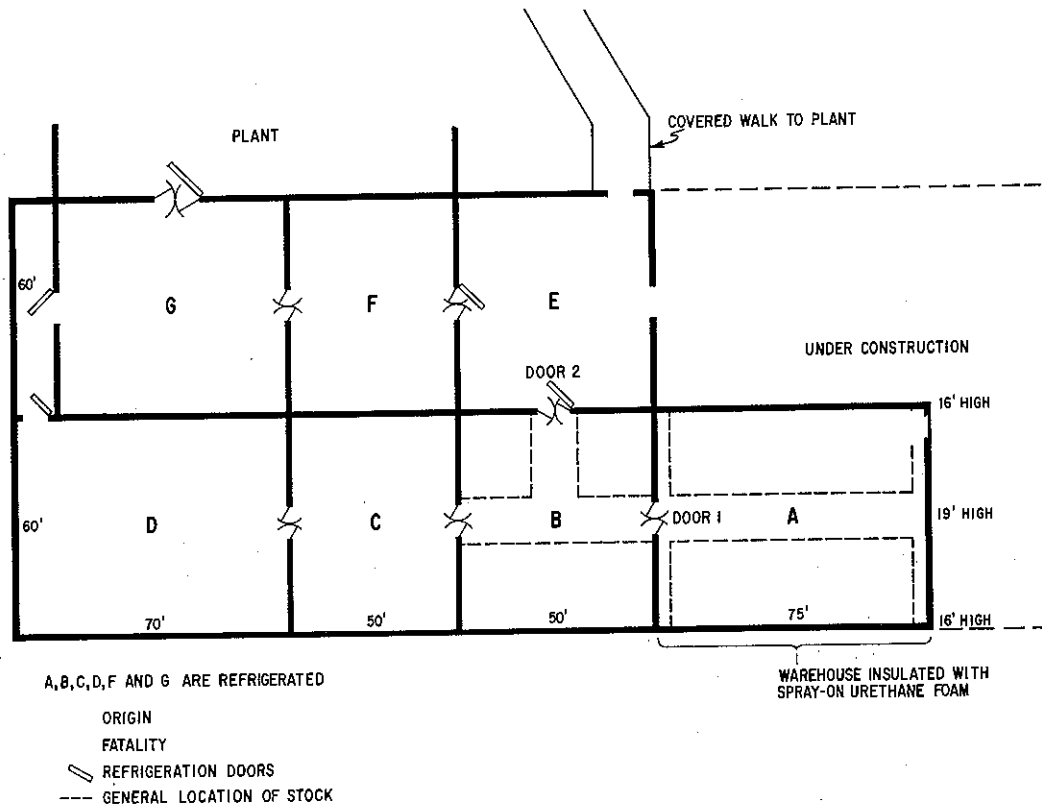
Figure 1.

10:00 am, the third hole was started. A few minutes later, the worker who was cutting the hole could see that a fire had started inside the warehouse. The construction workers ran into the warehouse and saw the urethane insulation burning near the area where the hole was being cut. One man was sent to call the Fire Department, which received the telephone alarm at 10:10 am. When the man who notified the Fire Department returned to the scene, attempts were being made to use extinguishers on the fire; however, the men doing so realized that the roof-level fire was too high to reach from the ground. Suddenly the room became filled with smoke, and the men crawled out. They all went out through Door No. 1, and then through Door No. 2. (See Figure 1.)

The urethane insulation was ignited from the unprotected side by the cutting torch. The intumescent paint retarded the spread of the fire; however, sufficient toxic products were given off to fill Warehouses A and B (see Figure 1), and to kill the construction worker (who,
