Fire Investigation Summary

Apartment Building Fire

**Bremerton, Washington
November 13, 1997**

National Fire Protection Association
Fire Investigations Department

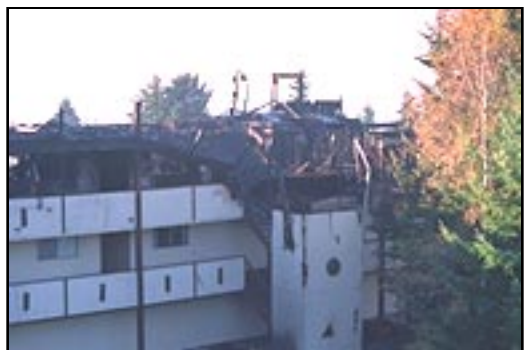
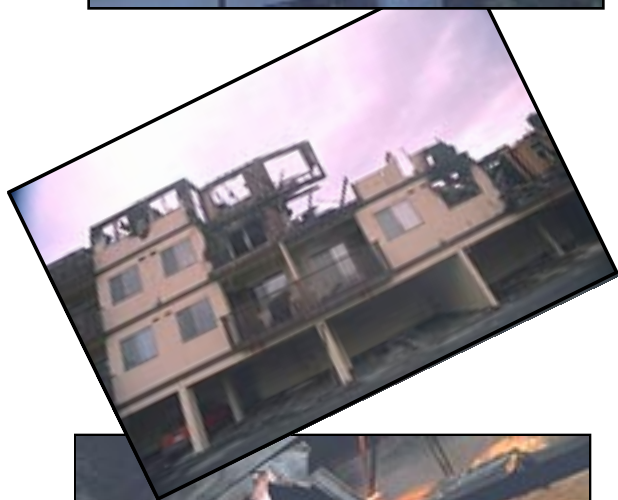
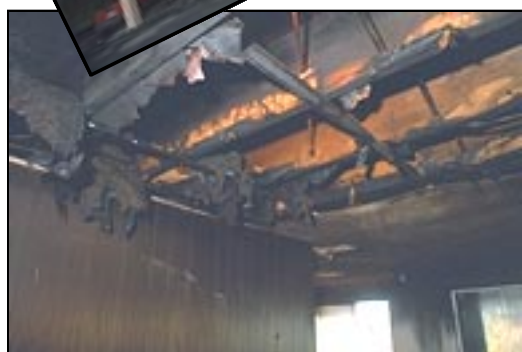
A fire in an apartment complex killed four elderly residents. The four-story structure was unsprinklered and only had smoke detectors that sounded within the individual units. The delay in the fire being detected, as well as the door to the apartment of origin being left open, allowed the fire to grow and spread rapidly.
