**Air Canada Regional Jet Accident
Fredericton, New Brunswick
12/16/1997**

**Presented By:
Captain Brian Boucher
Air Canada**

**Presented at:
The International Forum on Emergency and Risk Management
Singapore Aviation Academy
10-12 January, 2005**

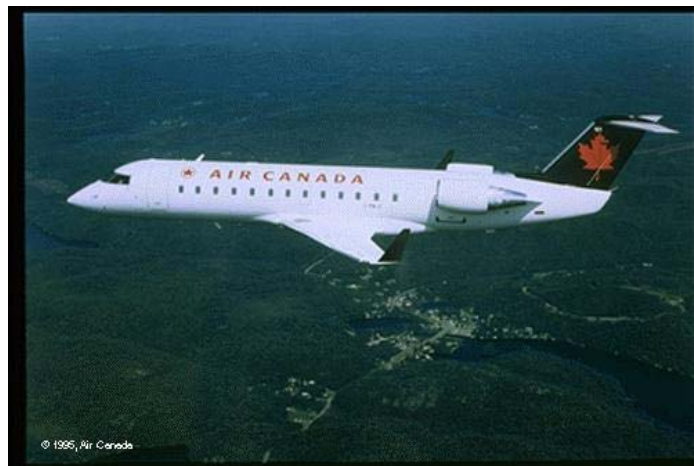
On December 16, 1996 an Air Canada Regional Jet departed Toronto on a regular scheduled flight to Fredericton at 21:34 GMT. The weather on arrival was reported as 30meters overcast 800 meters visibility. The approach in use was an ILS to runway 15. The approach ban into Fredericton was 60 meters 1000 meters visibility. The only approach on this runway was a category one. The first officer was flying the leg that evening and the Captain was also current as a Line indoctrination training Captain. The aircraft was flown down to 10 meters when the Captain ordered the First Officer to execute a missed approach. The aircraft pitched normally to 10 degrees when all of a sudden the aircraft aerodynamically stalled, fell to the runway, and then veered right of the runway at full power. After traveling 700 meters across the infield, it finally came to a rest against a large Hemlock tree at 2348 local time. There were 39 people on board and three crewmembers. 9 passengers were critically injured and the others received minor to no injuries.

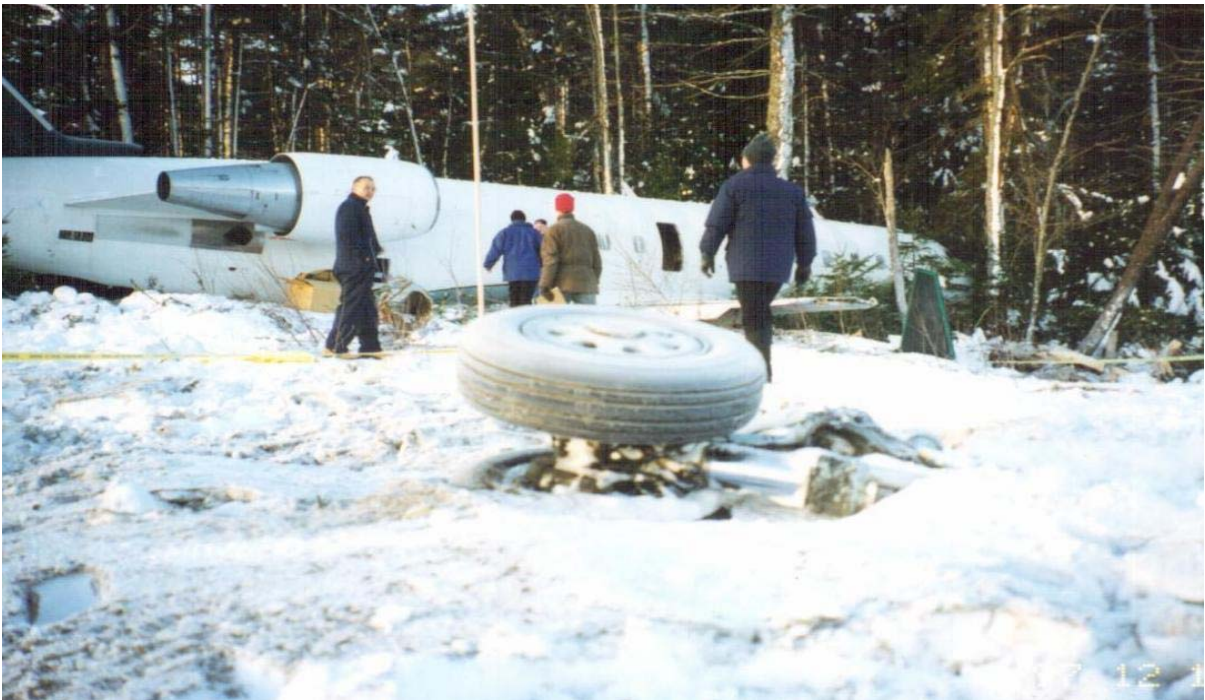
When the aircraft finally stopped moving, the Captain asked for the severe aircraft damage drill checklist. As they completed the checklist, it became apparent that both engines were still at full power and they were initially unable to shutdown the left engine because the thrust lever was impaired. Meanwhile, the passengers were getting instructions from the in charge F/A to start evacuating the aircraft. Fortunately the right engine shut down by itself as the passengers exited the right overwing exit. The left engine continued to run at full power even after the fire switches were pushed. It was only after the Captain put his foot on the instrument panels and applied all of his strength, that he was able to shut down the left engine.

There was a deadheading Flight Attendant who quickly exited the right side of the aircraft as shown and then assumed a leadership role. She assembled all the passengers who exited the right side and stopped them from re-entering the aircraft because the aircraft engine was still running. After the Captain shut down the engine, the F/A reentered the cabin to get the coats that the passengers left behind. The on duty F/A then gathered all of the ambulatory passengers and
