The Chicago School Fire

By Chester I. Babcock, Manager and Rexford Wilson, Engineer

NFPA Fire Record Department

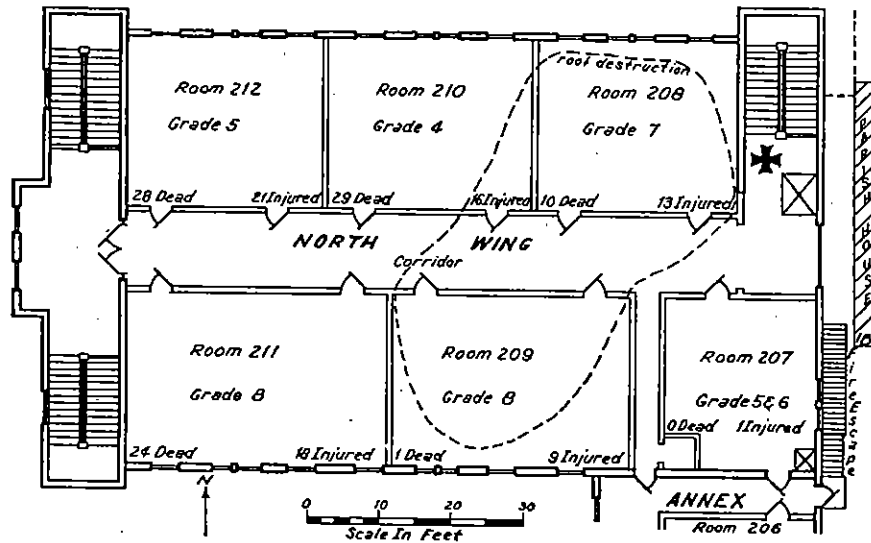
At 2:25 P.M. the teacher of Room 206 (see diagram 2) started two of her pupils on the normal routine of taking the class wastebaskets down to the boiler room incinerator. They returned at 2:30 P.M. to say that they smelled smoke. The teacher told her class to remain seated as she hurried to Room

207 to ask what she should do. After being advised of the smoke the teacher of Room 207 ran down the corridor to the principal's office in the middle of the south wing to alert her. The principal was not there as she was substituting for a sick teacher on the first floor.

The Room 207 teacher then returned to her classroom. She and the teacher of Room 206 decided to take their classes out of the building. The pupils in Room 207 went out through the cloakroom and down the fire escape stairs, while those in Room 206 went down the annex stairs and outdoors. Smoke was already at head level in the second story corridor.

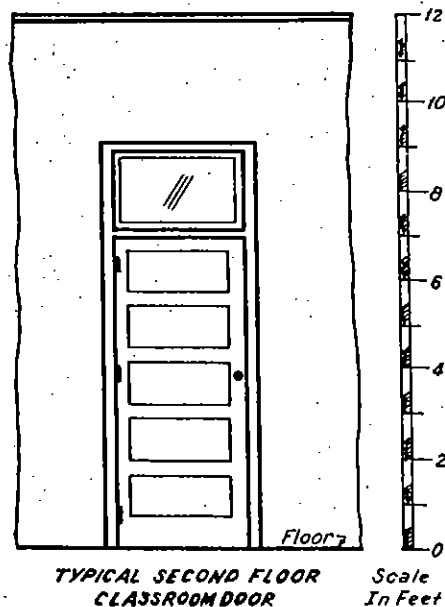
Room 207

In Room 207, at the top of the rear stairwell (see diagram 2) the 24 fifth grade and 16 sixth grade pupils had just settled down after returning from a music lesson in another part of the building. The door to the corridor was closed.
