# Fire Investigation Summary

## Church Fire

Lake Worth, Texas

February 15, 1999

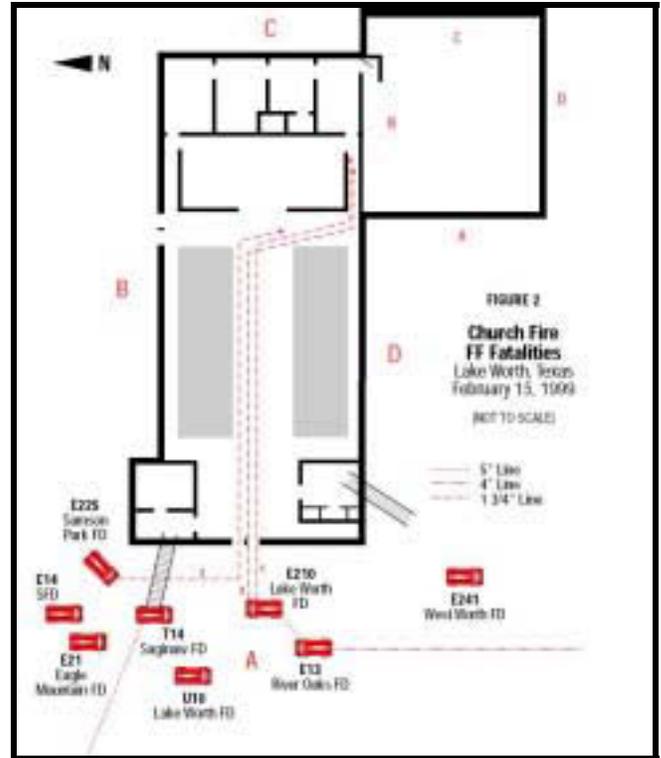
The collapse trapped the five fire fighters in the interior of the building in the southeast corner of the church near the wall shared with the Fellowship Hall. An initial accountability check revealed that two fire fighters were trapped in the building. A rescue attempt was attempted through the Fellowship Hall, and as a fire fighter entered the hall he found a door near where the trapped fire fighters were believed to be located. He was able to remove two of the five fire fighters inside the building, but was unaware that there were additional fire fighters trapped inside. Conditions deteriorated rapidly immediately following this rescue. A second more accurate accountability check was made, and it was realized that three fire fighters were still missing, two from River Oaks and one from Samson Park.

As the fire was being extinguished, the three fire fighters were found. Two were in a short corridor adjacent to the altar and the third was found in one of the offices on the east side.

State and local fire marshals have determined that the fire was incendiary in nature. No arrests have been made in this incident at the time of this report.
