An Atrium Fire

JOHN A. SHARRY

NFPA Fire Record Department Specialist

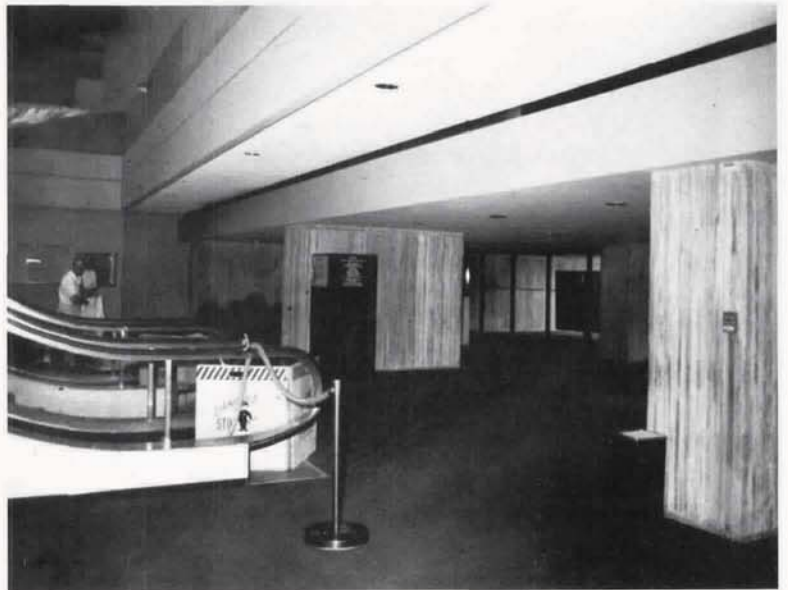
Figure 2

LOBBY LEVEL

The Blue Max night club was located on the second floor of the hotel (see Figure 2) and was separated from the atrium by a plywood-on-wood-stud partition. The entrance doors were located directly below interior guest-room balconies. The club measured 60 feet by 80 feet and was divided into two areas, a bar area and a night club.
