# Fire Investigation Summary

## Church Fire

Lake Worth, Texas

February 15, 1999

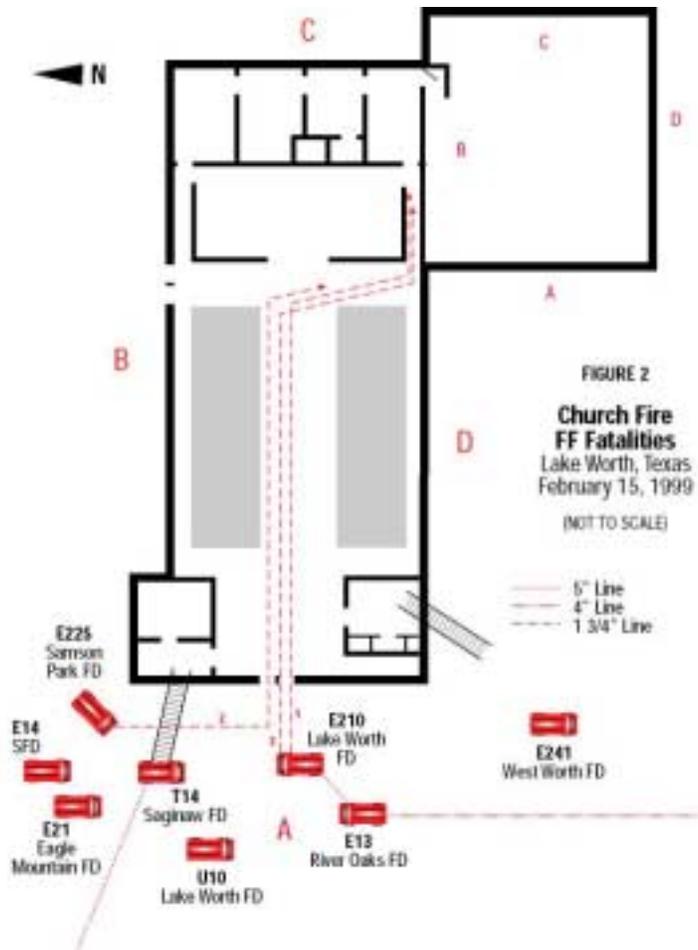
This fire fighter re-entered the building, where he and the fire fighters from Eagle Mountain heard what has been reported as a loud popping noise. They began to rapidly move to escape from the building, yelling for the others to evacuate. As they were doing this, the roof over the sanctuary collapsed catastrophically. One fire fighter was forced to crawl under the collapsed roof, which was supported on top of the pews.

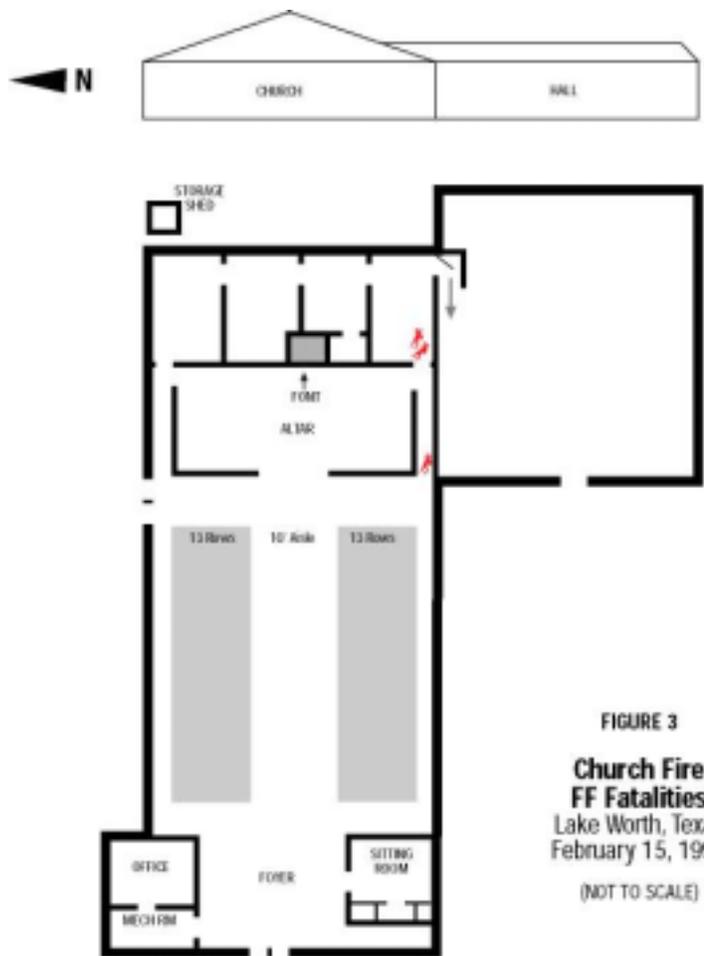
An opening was made in the south exterior masonry block wall, near where the church and Fellowship Hall connected, in an effort to gain entry and locate the trapped fire fighters. Once the wall was breached, two fire fighters were found immediately adjacent to the altar, with the third several feet away in the aisle. All three were later removed from the building.

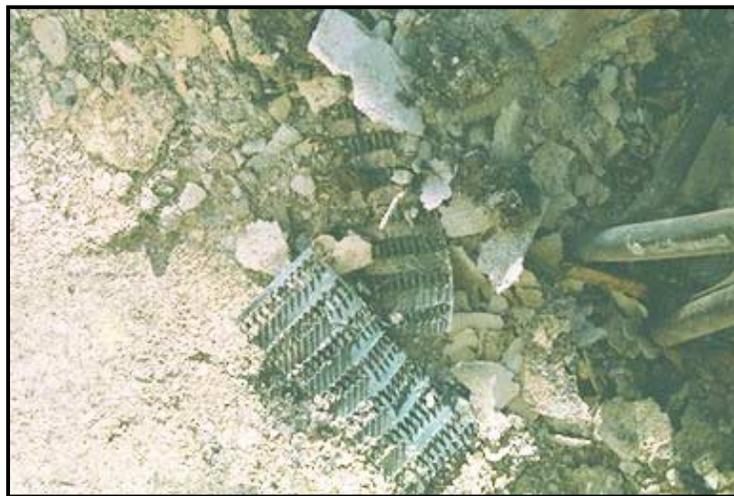
These metal connectors have short teeth that bite into the wood, creating a strong, stable connection. In a fire, though, they may help weaken the wood. When the U.S. Forest Products Laboratory conducted limited fire tests on gusset plates, researchers found that they reflected the heat away from the connection during the initial stages of a fire,

but as the fire progressed, they transmitted heat into the wood, charring it. Examining the wood underneath and next to the plate after the tests, researchers found similar damage and concluded that it wasn't the plate itself that had failed—it was the wood the plate's teeth had penetrated.
