**BED AND BREAKFAST
ALLENSTOWN, NH
JULY 17, 2001**

**FIRE
INVESTIGATIONS**

Bed and Breakfast

Allenstown, NH
July 17, 2001

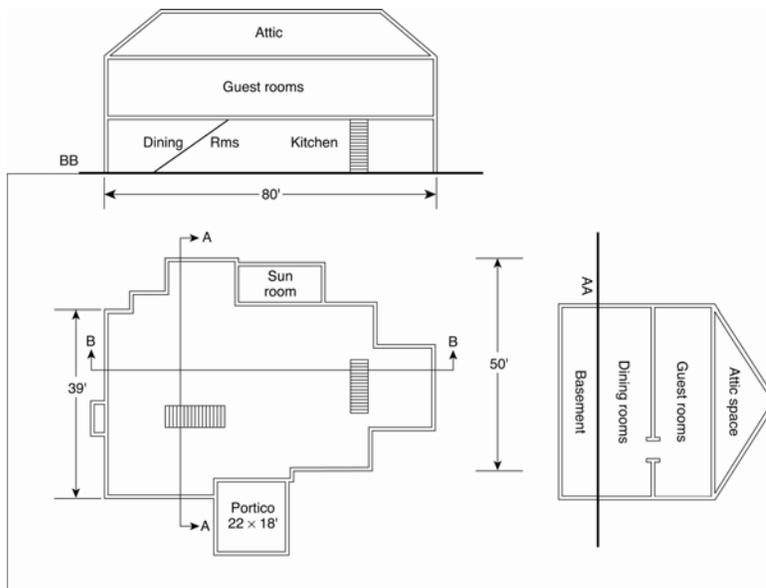
Figure 1-Building Layout and Dimensions

The facility was a two-story (plus partial, finished attic), colonial style wood-frame building operated as a bed and breakfast facility. (For the purpose of code analysis this building would be considered three stories due to the attic sleeping area.) The building was reportedly constructed in 1760 and was utilized as a residence for many years for a local mill owner and his family before being modified for lodging and dining. According to town records, modifications were made to the structure in 1900, 1950, and 1998 (see Figure 1 and Photo 1).

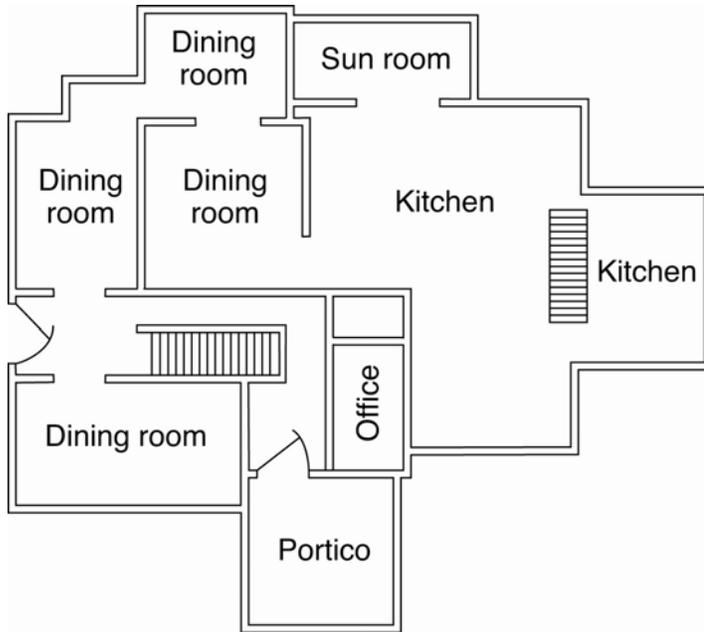
Figure 2 – First Floor Layout.

The first floor of the building contained three interior dining rooms and a large kitchen area. A “sun room” dining area was located adjacent to the kitchen on the southwest side of the building (see Figure 2).

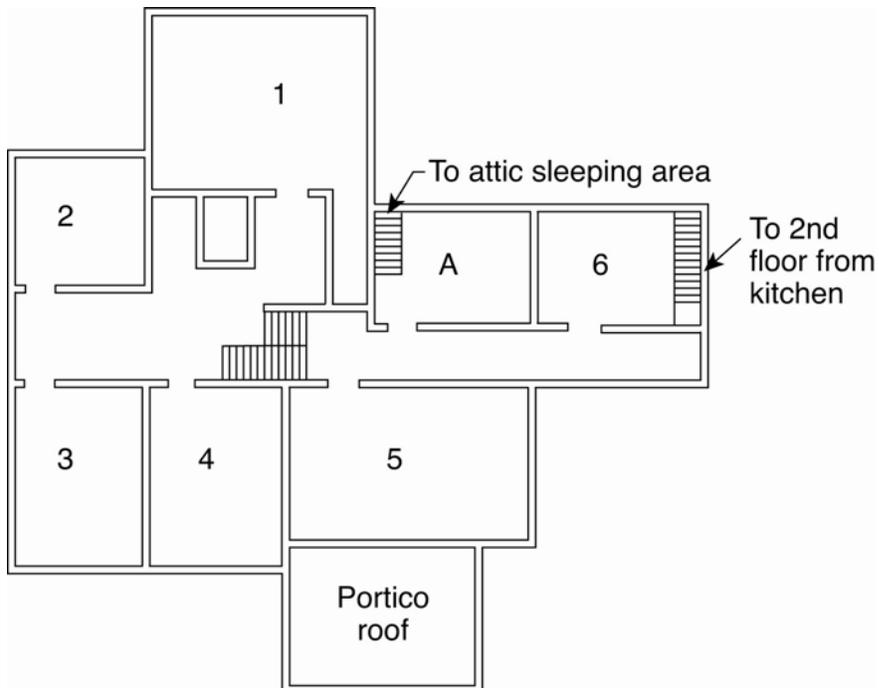
Figure 3 – Guest Room Layout-Second Floor

The second floor contained six guestrooms, and a guest room converted into a partial apartment area, occupied by the owner. Access to the second floor was via two stairwells. A central open stair was located adjacent to the front entrance to the building on the first floor and terminated in the center of the second floor. The other stair was located in the south portion of the building and provided access to the kitchen area from the second floor (see Figure 3/ Photos 2 and 3).
