CRUISE SHIP FIRE
Port Canaveral, FL
March 9, 1984

Investigation Report

Scandinavian Sea Cruise Ship Fire
Port Canaveral, Florida
March 9, 1984

Tom Timoney
Fire Protection Specialist
Fire Investigations and Applied Research Division
National Fire Protection Association

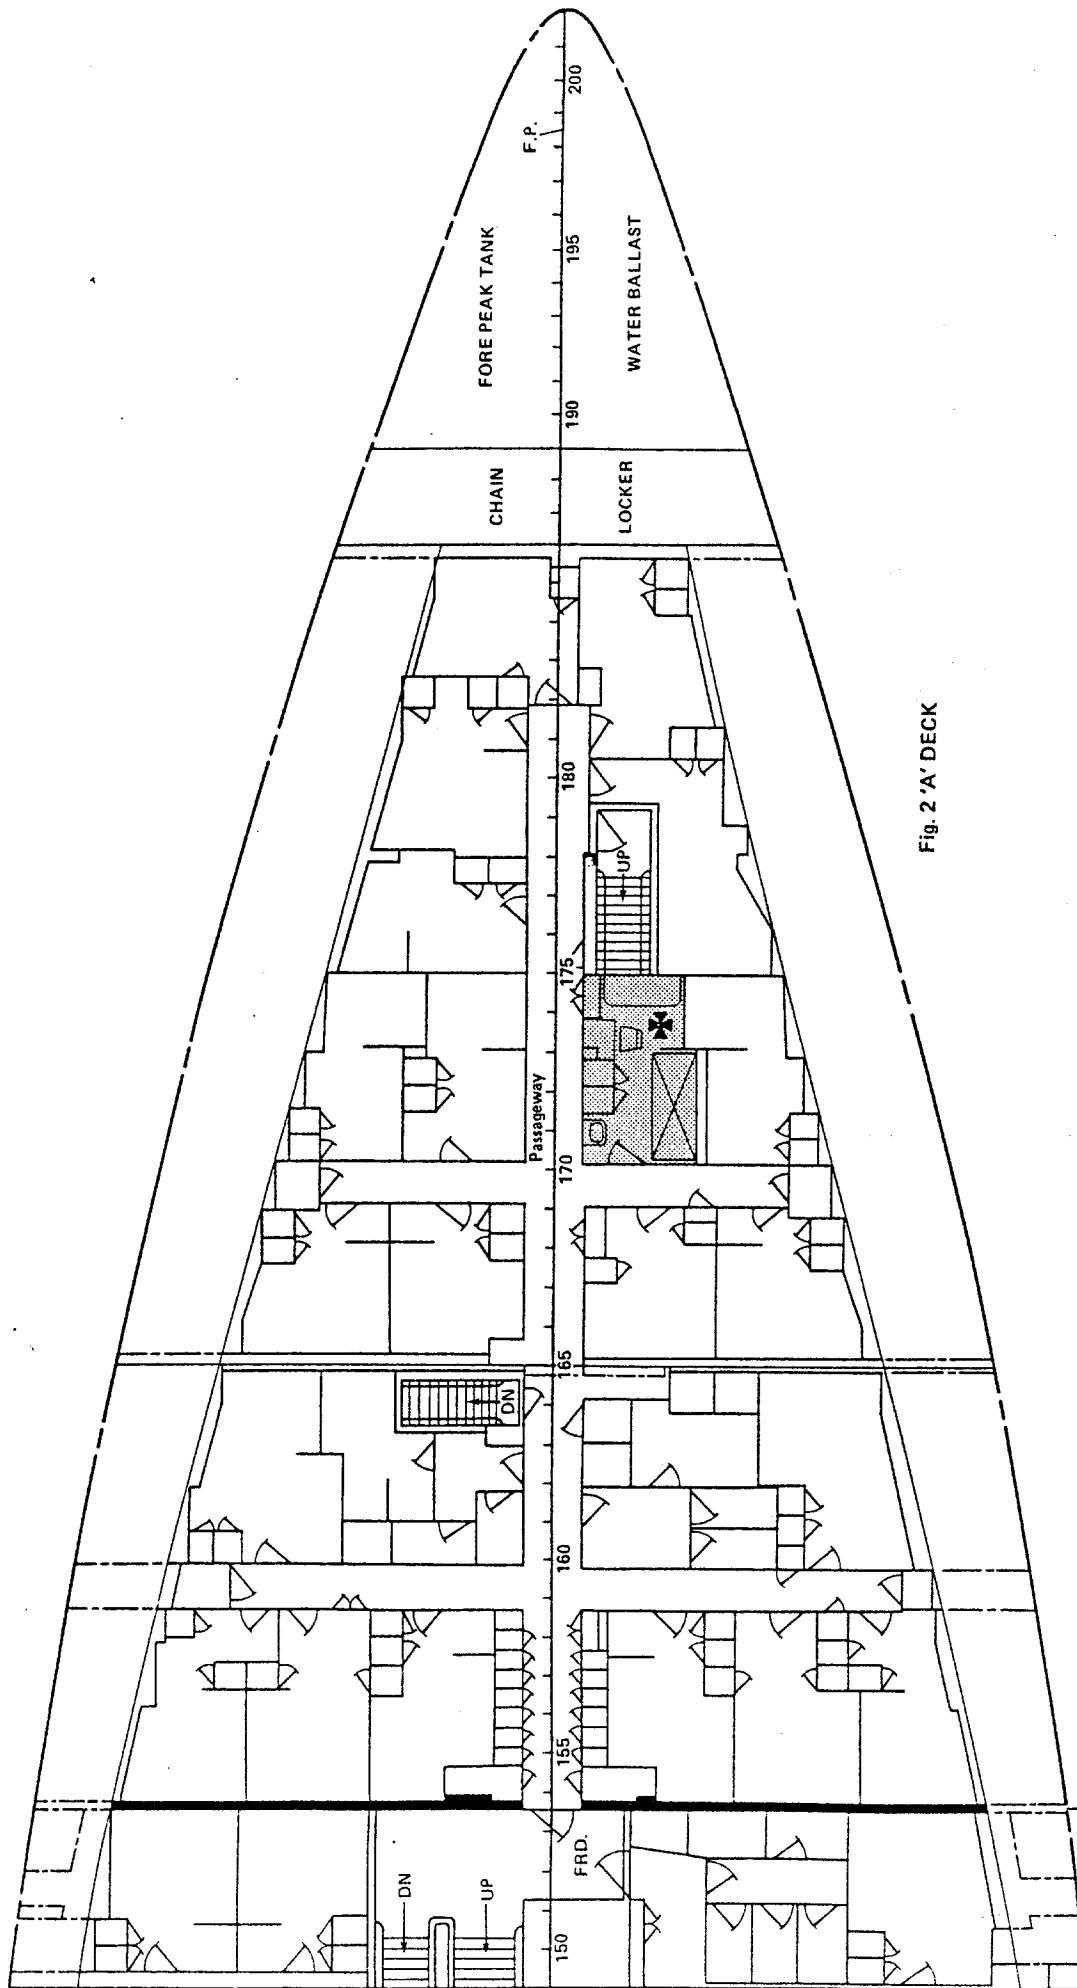
Fig. 2 'A' DECK

At the time of this report, the cause of this fire remained undetermined. The crew member who discovered the fire in cabin 414 described finding a 2-foot circular area of the carpeting burning in the rear of the cabin. He was unable to extinguish the fire with portable hand extinguishers and notified the bridge before retreating from the area to don SCBA.
