CHURCH FIRE

St. Louis, MO

April 28, 1994

SUMMARY FIRE INVESTIGATION REPORT

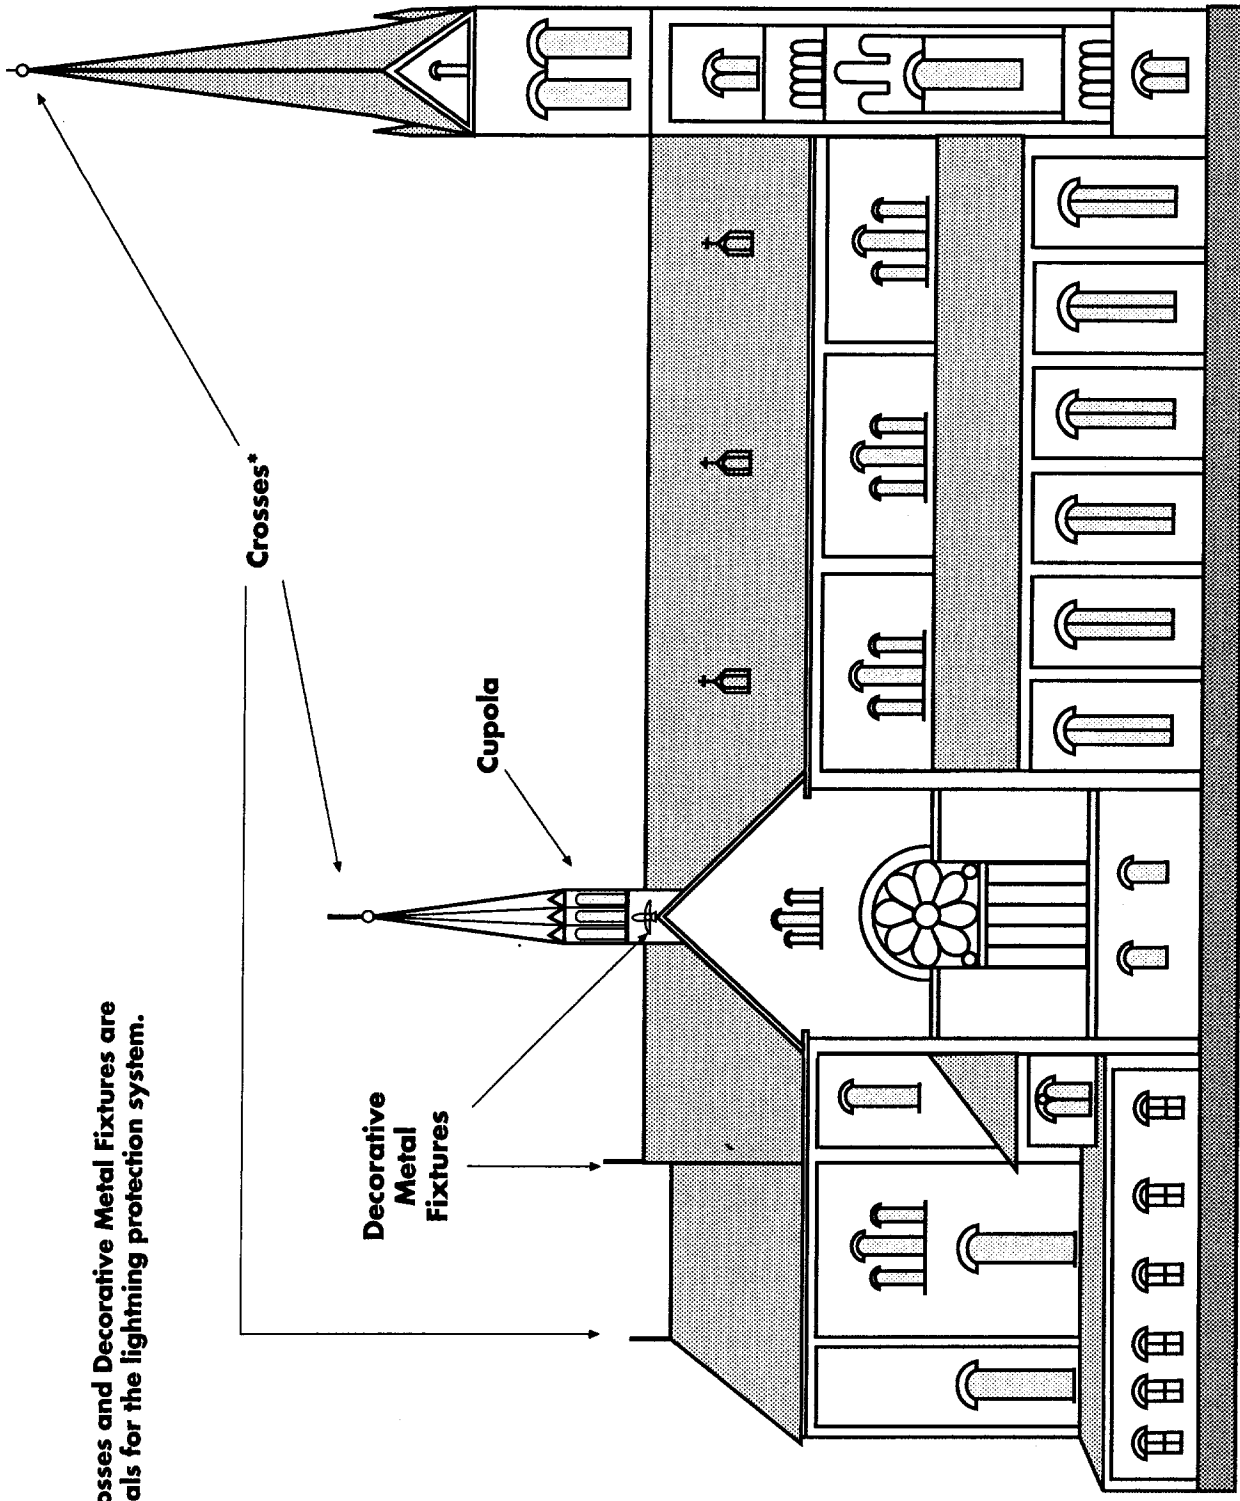
**East Side Elevation
St. Anthony of Padua Church
Figure 1**

St. Anthony of Padua Church was located on top of a hill and was the tallest structure within several miles. The church was built between 1908 and 1910 and was of Romanesque design. The large cathedral-like building (see Figure 1) was in the shape of a cross, with its longest part, the nave, in the north/south direction. The nave was approximately 220 feet long and 75 feet wide. The transepts, small wings creating the building's cross-shape, were approximately 26 feet deep and 36 feet wide and were constructed in the east/west direction. These wings were located approximately 64 feet from the south end of the building. Two steeples, approximately 175 feet high, had been constructed at the north end of the building; one steeple was on the east of the building's main entrance and the other steeple was on the west side of the main entrance.

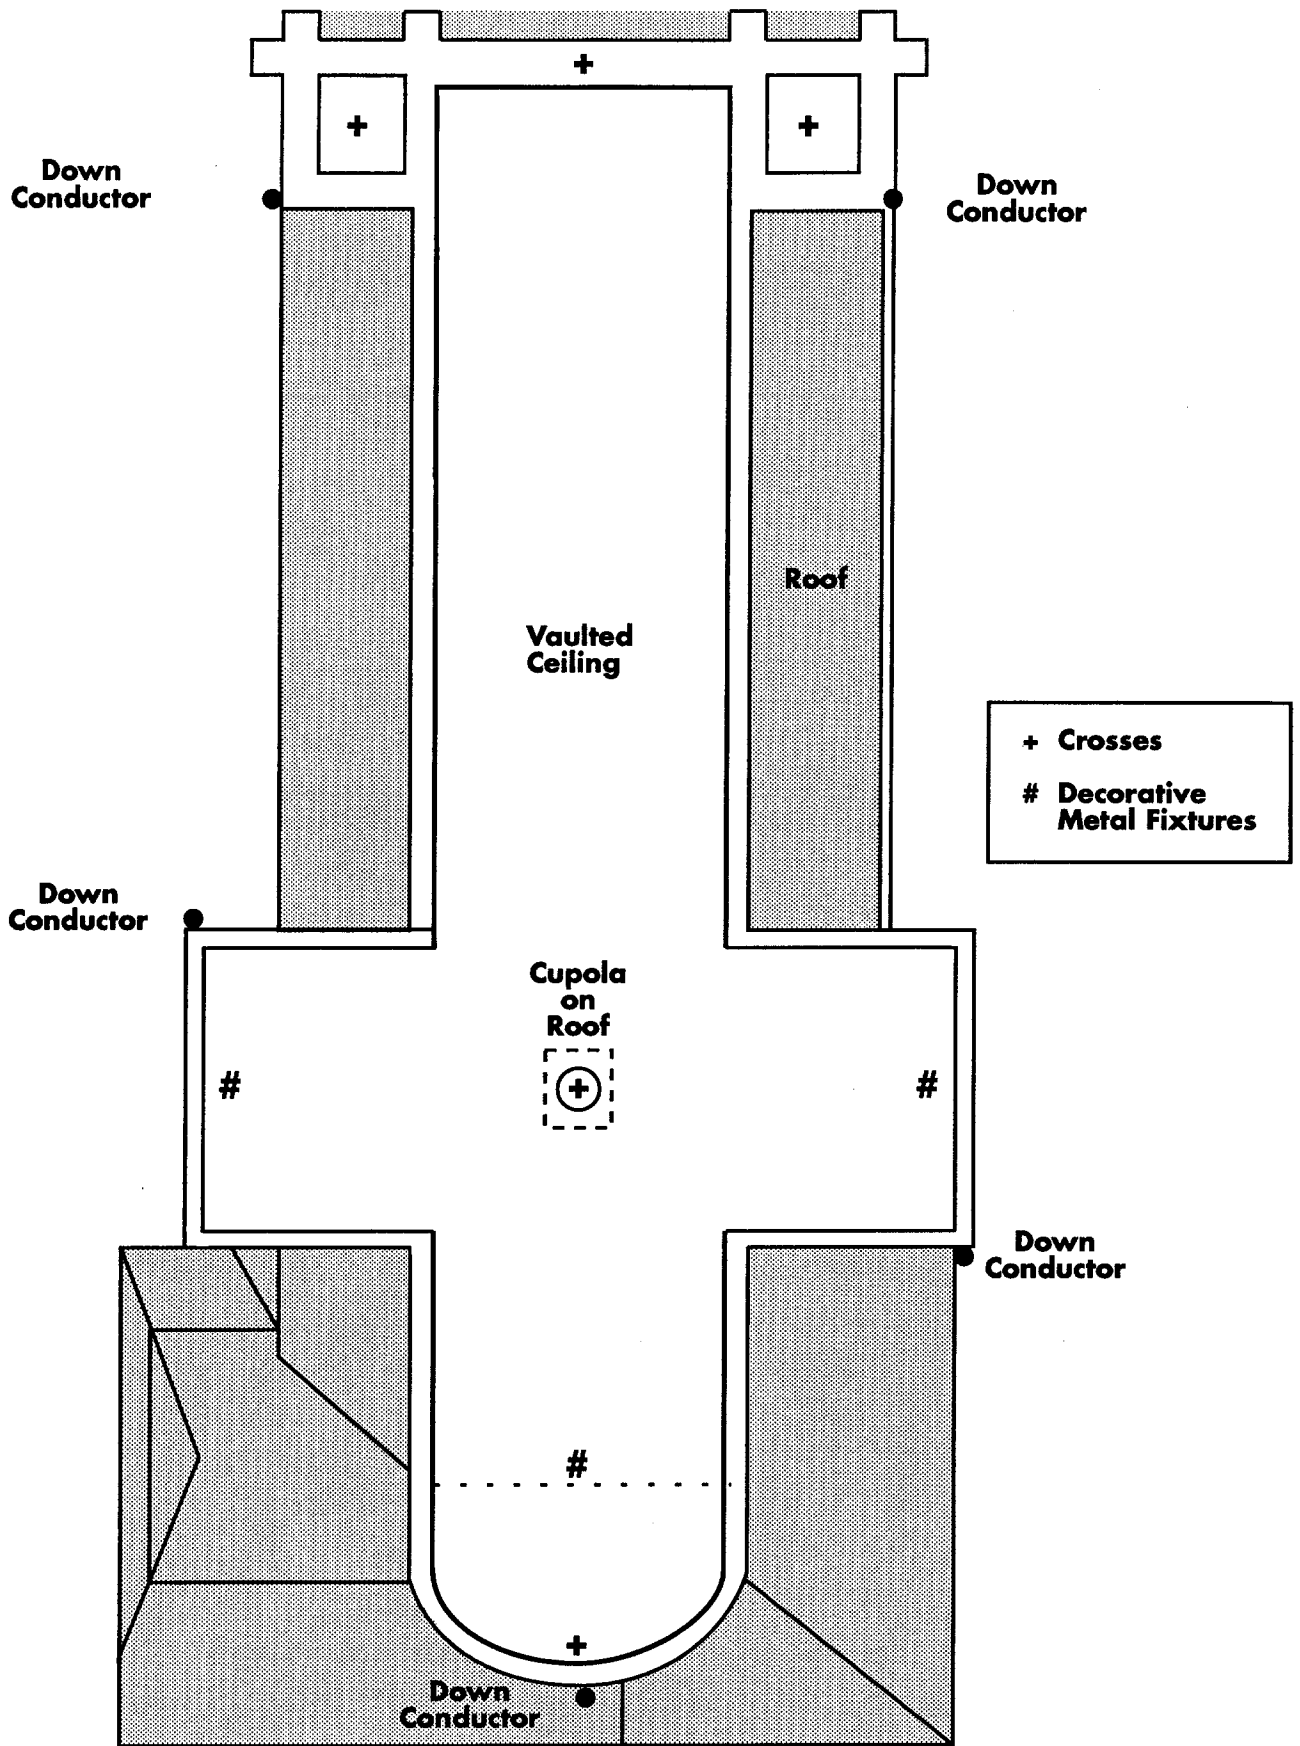
Plan View
St. Anthony of Padua Church
Figure 2

Most of the air terminals on the building were designed to blend into the church's exterior detail. Five air terminals were shaped like crosses. (See Figure 2) Two of these air terminals were installed on top of large steeples at the front (north end) of the church; the third cross-shaped air terminal was installed on the gable end at the front of the church, the fourth was on top of the cupola, and the fifth cross was installed on the roof at the south end of the building. In addition, three decorative metal fixtures also served as air terminals. One of these fixtures was installed toward the south end of the building's roof. Another decorative metal fixture was located on the ridge of one transept's gable end, and a third fixture was located on the ridge for the other transept's gable end. The last air terminals were typical metal rods and were installed on top of a chimney.

*Note: Crosses and Decorative Metal Fixtures are Air Terminals for the lightning protection system.
