TECHNICAL NOTES

Fire Hazard Assessment of Lead-Acid Batteries

Trent Parker, Larissa Obeng and
Qingsheng Wang, PhD, PE, CSP

July 2020

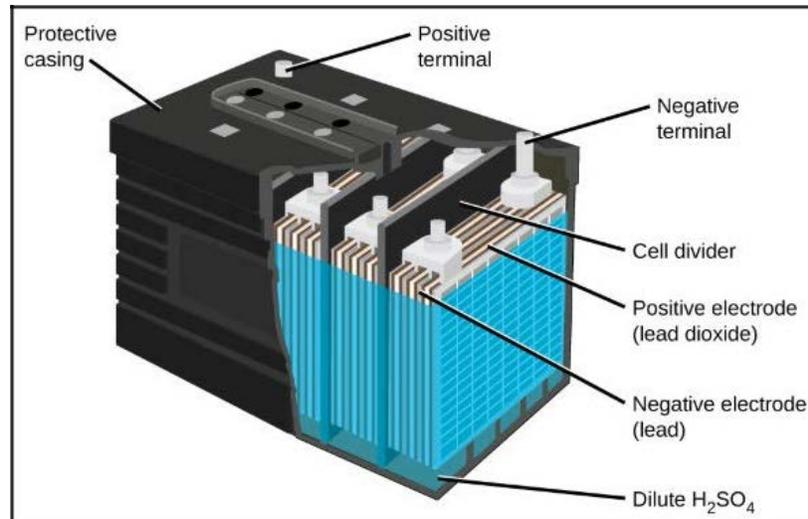
Figure 1: Lead-Acid Battery Diagram

Lead acid batteries were invented in 1859 and were the earliest type of rechargeable batteries to be used in commercial applications. They consist of flat plates submerged in a dilute electrolytic solution containing sulfuric acid (H_2SO_4), with the anodes consisting of lead dioxide plates and the cathodes consisting of lead plates, as shown in Figure 1.
