FIRE INVESTIGATION REPORT

Delta Flight 1141 Crash  
Dallas/Fort Worth Airport  
August 31, 1988

Prepared By  
Martin F. Henry  
Director  
Public Fire Protection Division  
National Fire Protection Association

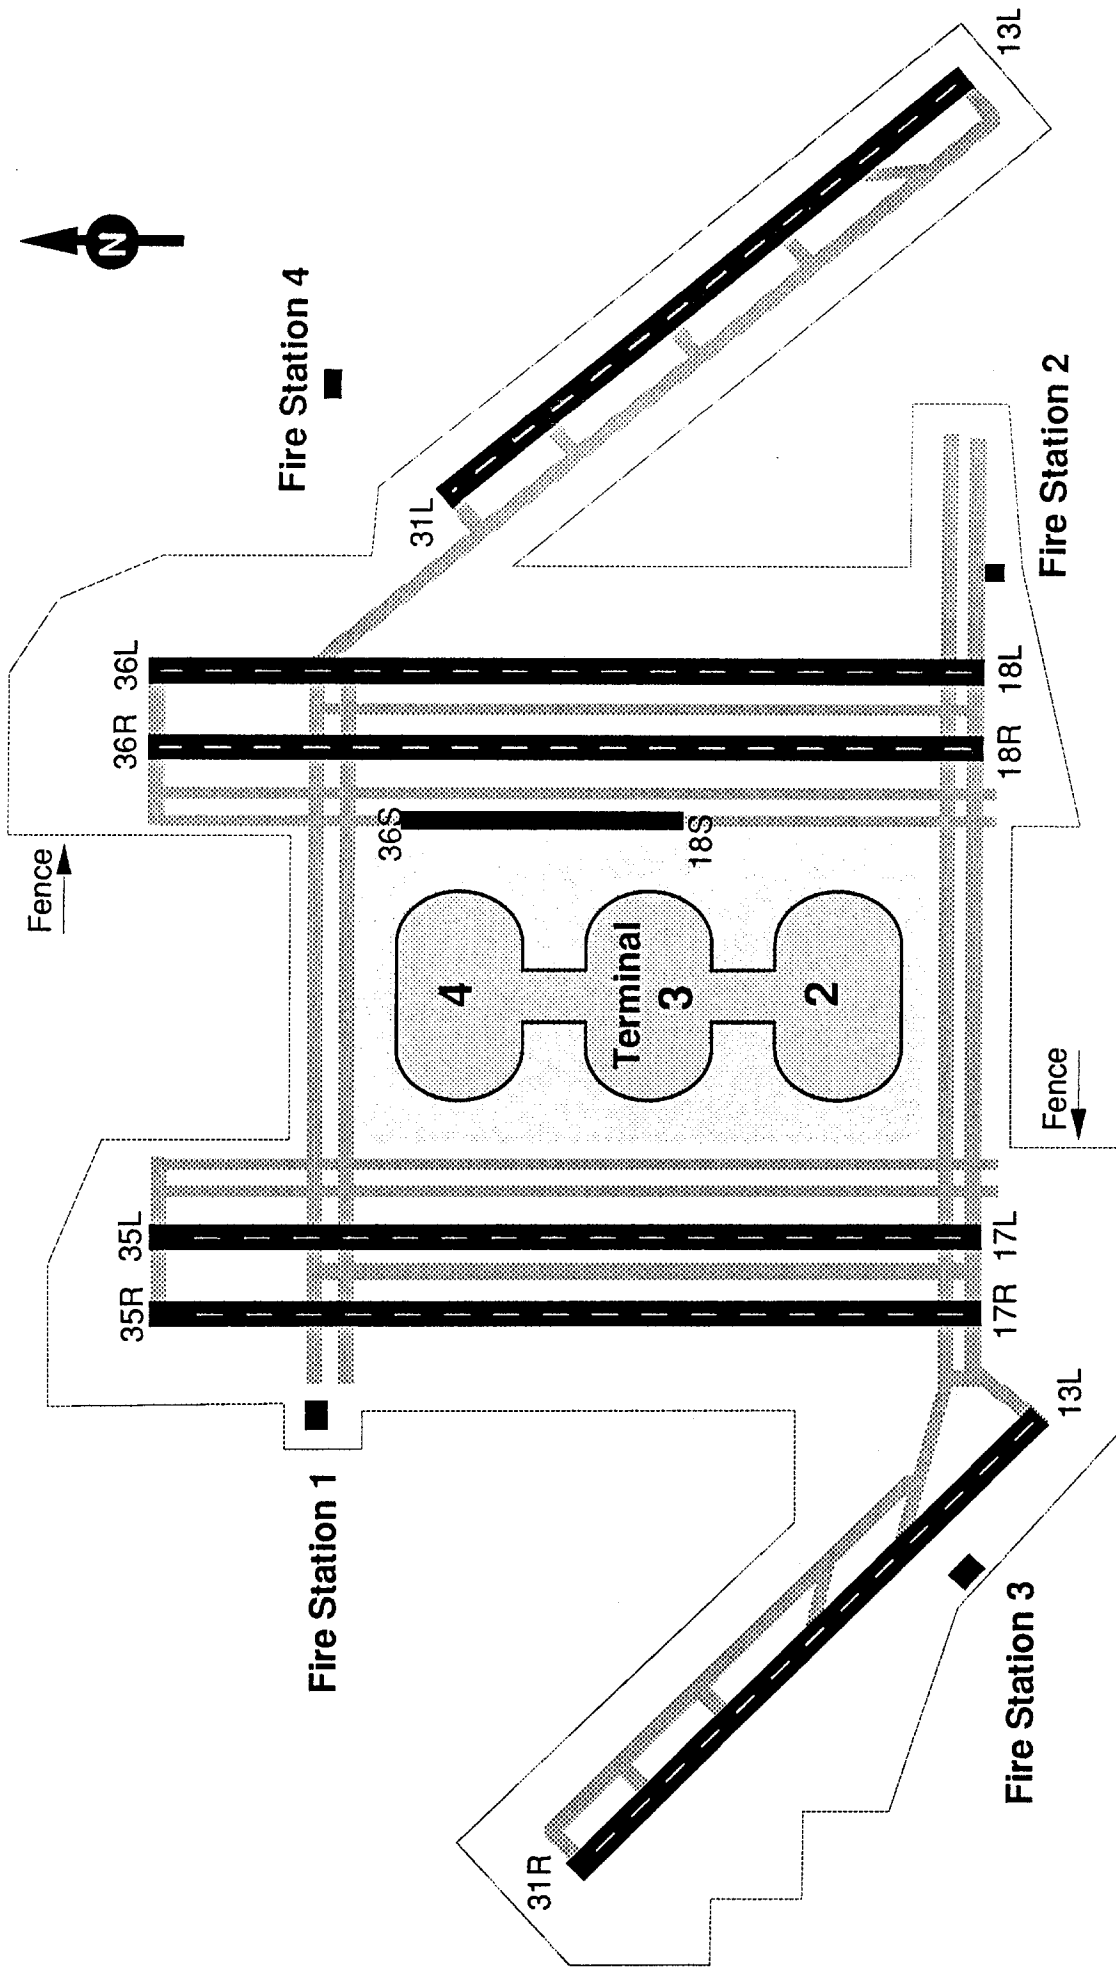
**Figure 1:**  
 Dallas-Ft. Worth Airport  
 Fire Station Location  
 and Approximate Crash Site

Approximate Final  
 Position of Aircraft

Flight 1141, with a total of 108 persons onboard a Boeing 727 in service for Delta Air Lines, took off with what was considered a moderate load in weather that was mild and clear. The fuel load totaled 32,000 pounds (4776 gallons). As the aircraft traveled south down the 11,388-foot-long runway, it appeared to assume proper takeoff attitude, but it was not achieving normal altitude. It began to lift off at a point about 8500 feet down the runway. The tail of the plane reportedly struck the runway; the right wing dipped and may have touched ground at the edge of the runway. A correction to the left caused what was described as a rotating, or rolling, takeoff and the plane then came down, experiencing a low impact crash just off the end of runway 18L. (See Figure 1.)
