**GASOLINE STORAGE TANK
EXPLOSION AND FIRE**

Newark, NJ
January 7, 1983

Summary Investigation Report

Gasoline Storage Tank Explosion and Fire
Newark, New Jersey
January 7, 1983
1 Fatality

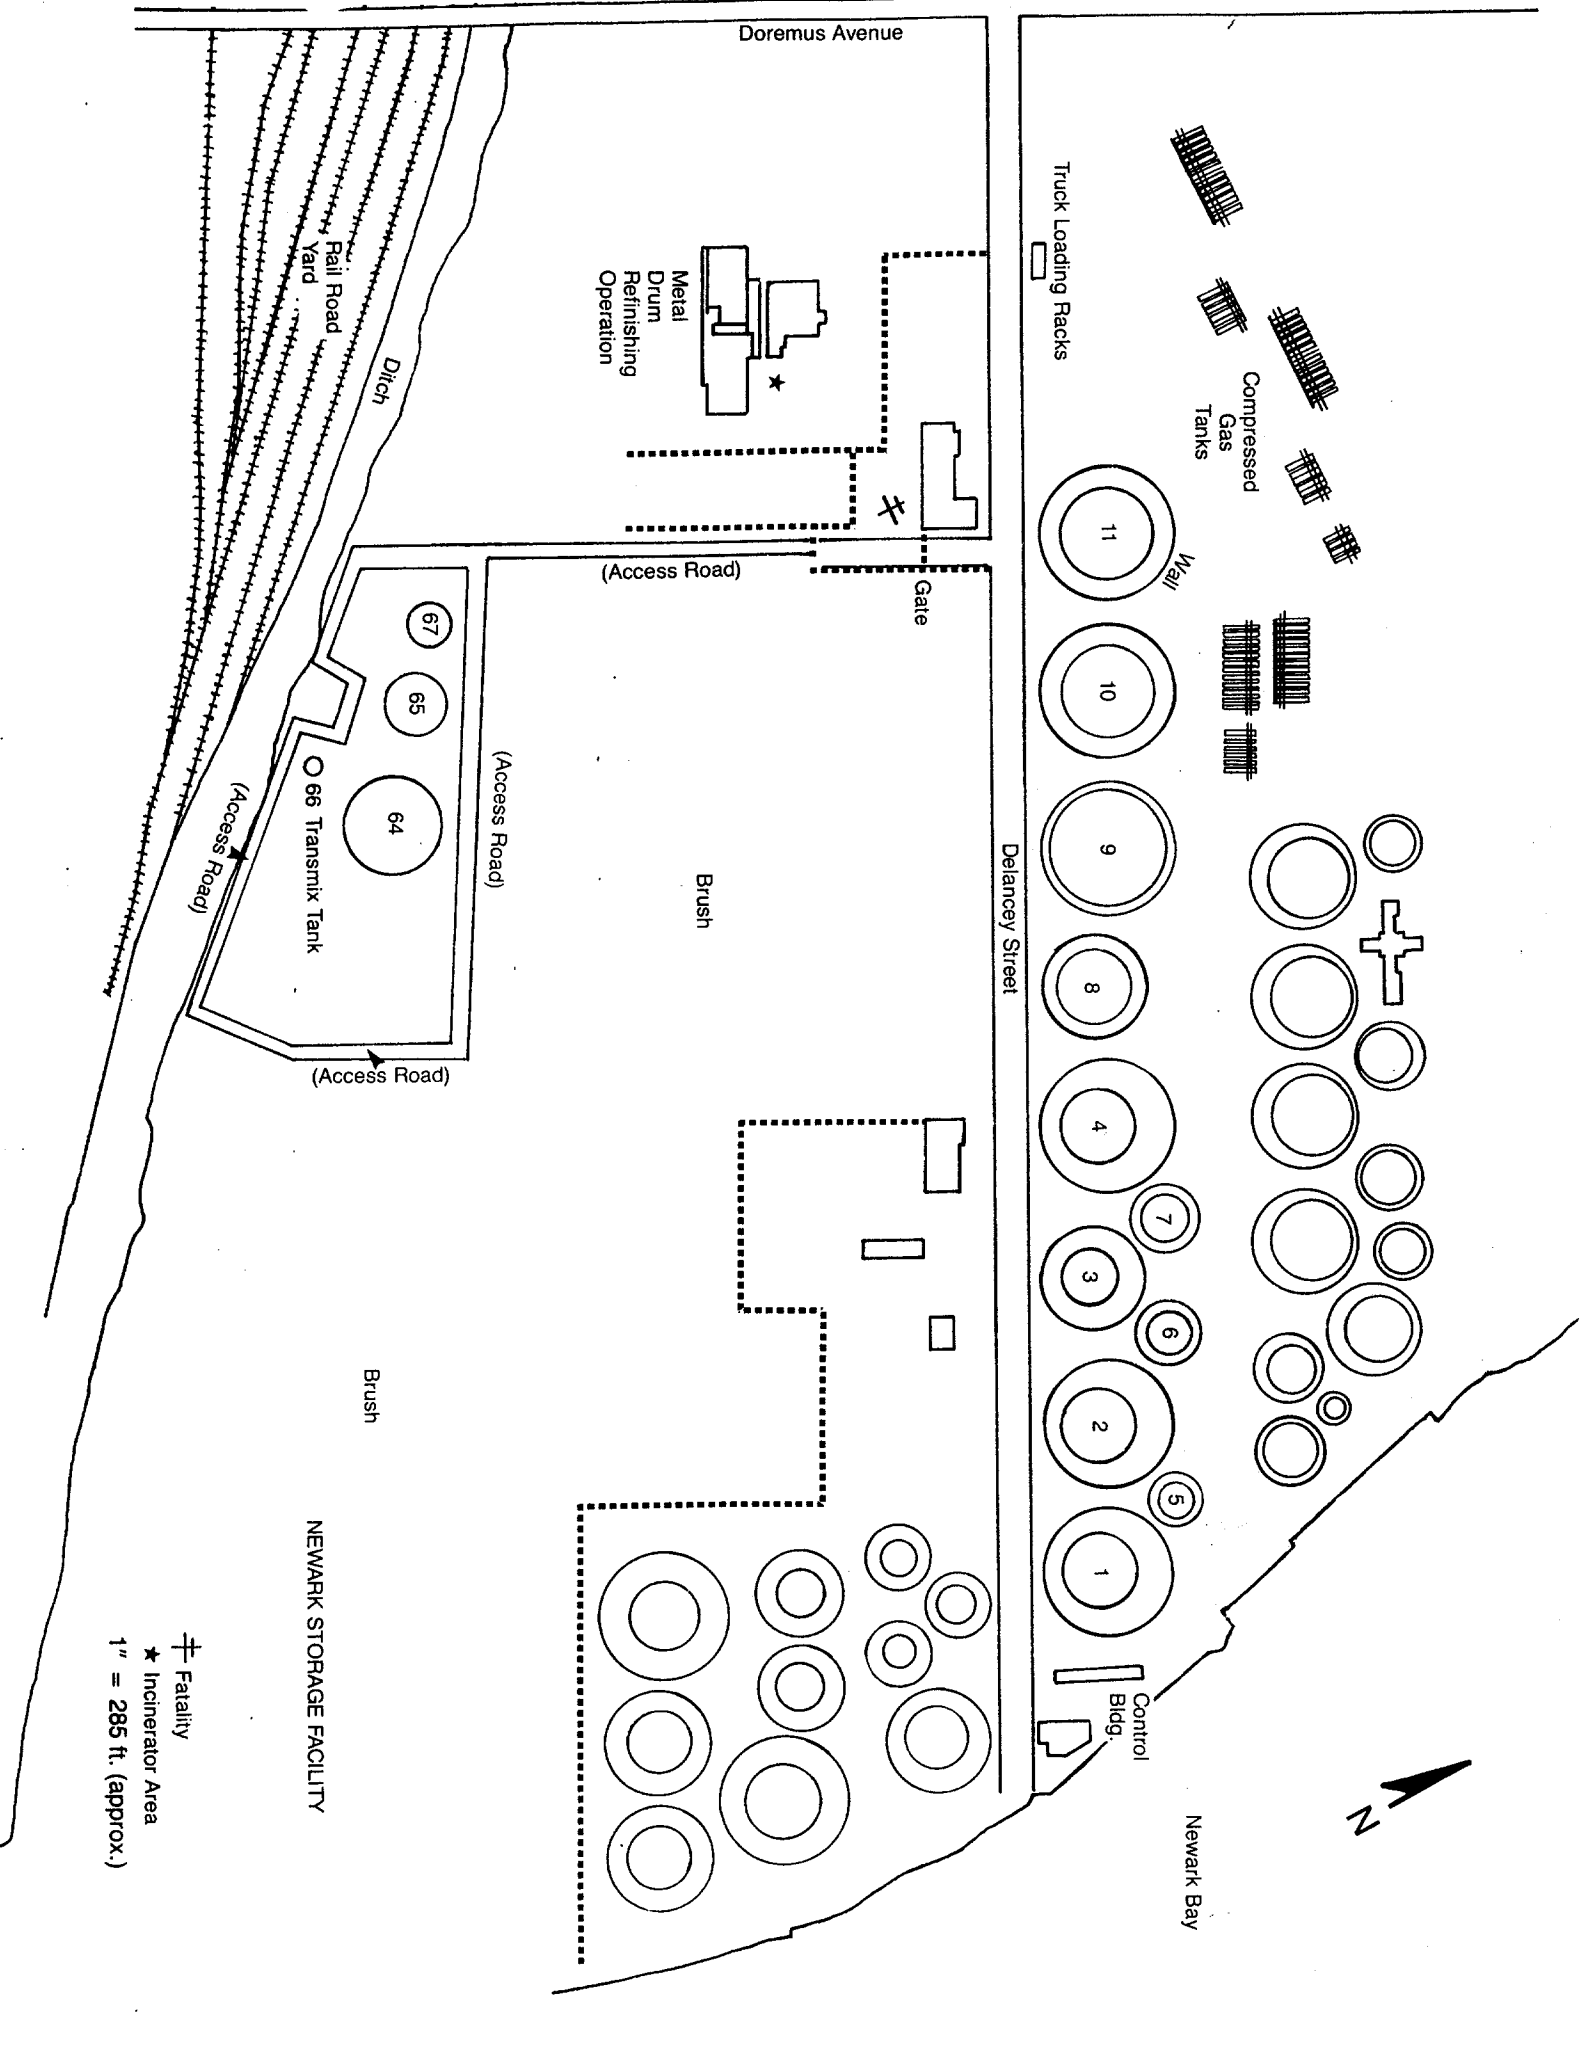
Doremus Avenue

Truck Loading Racks

While apparently leaving the premises because of the emergency, one employee was caught in the open at the moment of the blast and killed. The burned body was found near the charred automobiles at the truck terminal area (see diagram and photo No. 4). Eventually, 24 persons were treated for various injuries resulting from the incident. Those injured included railroad, tank storage facility, and drum refinishing company employees. There were no firefighter or police injuries. It is speculated that the large blast was the ignition of the vapor and large spill at the diked area of tanks Nos. 67, 65 and 64.
