Technology

Efficiency and Effectiveness

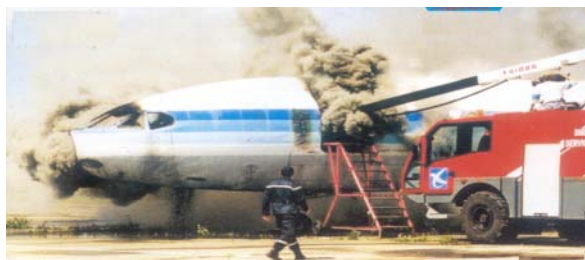
Extension into harms way.
