Full-Scale Validation Tests of a Forensic Methodology to Determine Smoke Alarm Response

Hughes Associates, Inc.

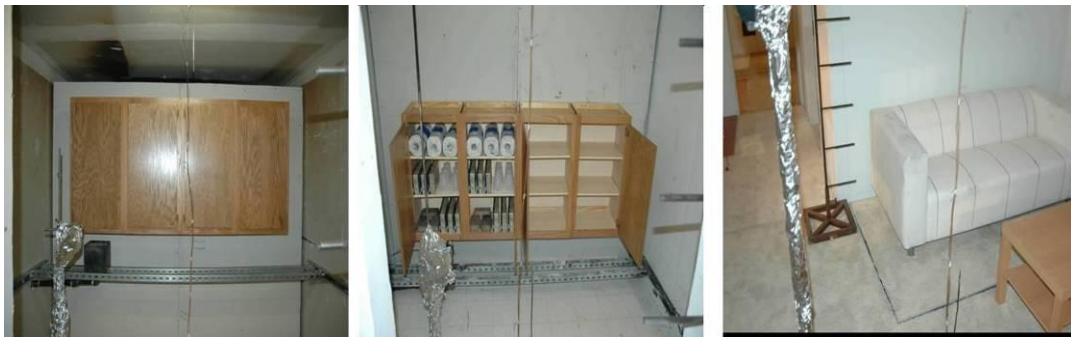
Figure 2: Photograph of elevated cabinet array (left), floor-level cabinet array (middle), and upholstered sofa (right) fire test setups.

enclosure. Living room fire scenarios utilized an upholstered sofa comprised of wood framing, polyurethane foam cushioning, and cotton fabric upholstery. Photographs of each of the three fire scenarios are presented in Figure 2.

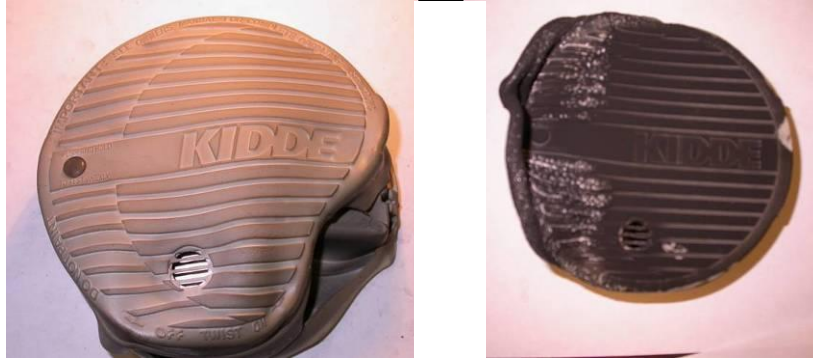
Figure 4: Photographs illustrating the different levels of soot deposited on alarms exposed to varying fire conditions.

determine if sufficient soot deposition was present to make a determination as to activity of the alarm. If sufficient soot was present on the alarm to make such a determination, the inspection continued; if insufficient soot was present then the alarm was identified as an indeterminate case. Photographs illustrating this dichotomy are presented in Figure 4.

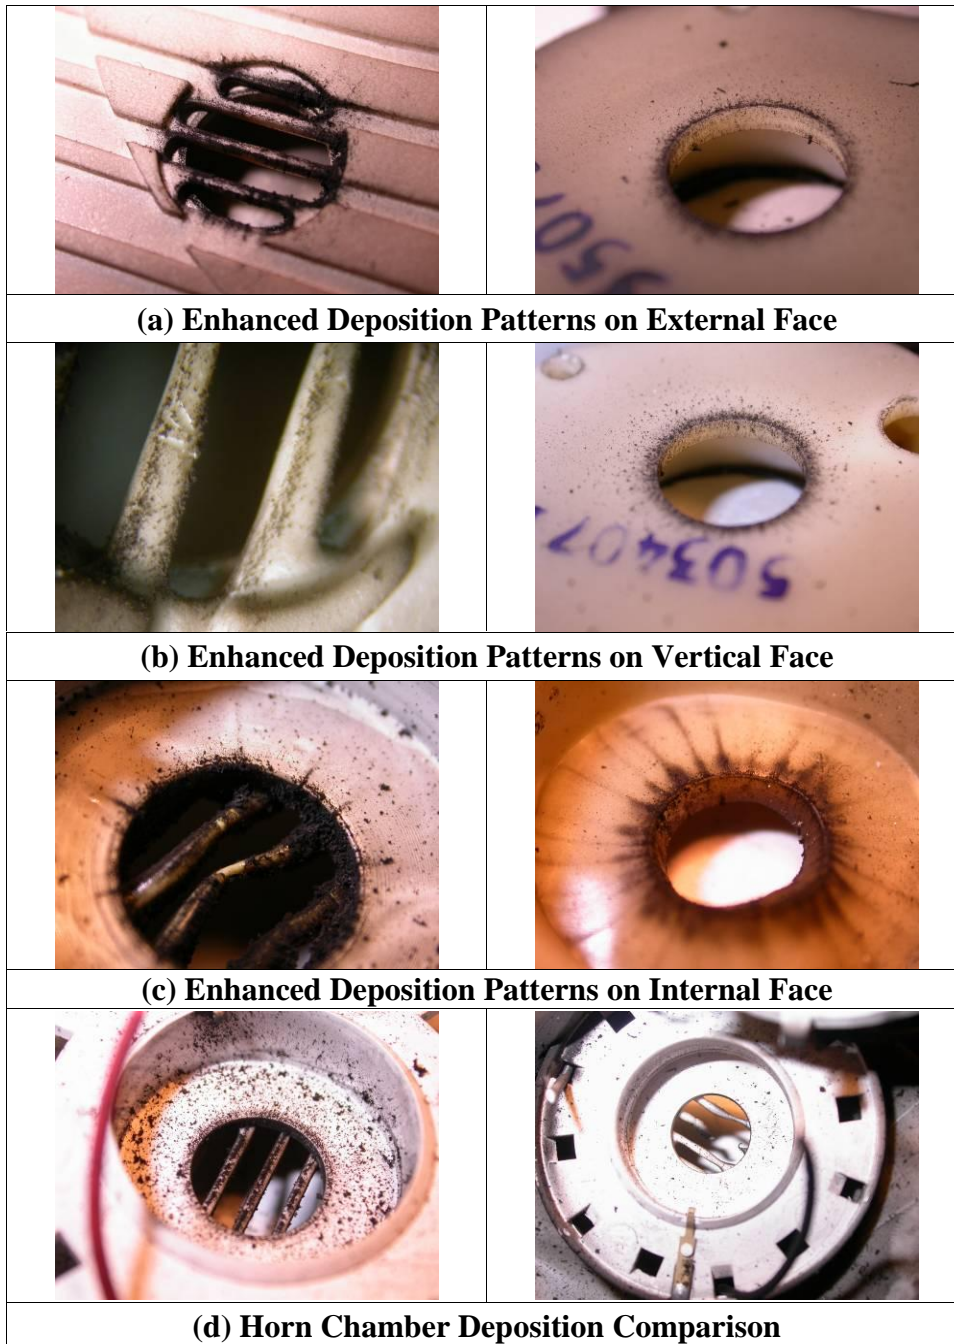
Figure 5: Photographs of observations obtained during examination of smoke alarms.

Provided that sufficient soot deposition was identified a series of four observations were made via both macro- and microscopic inspection. Initially, a macroscopic examination of the external face of the alarm was conducted specifically examining the surface area proximate to the alarm horn opening. This was followed by a microscopic inspection of the external surfaces. A similar process was performed for both the vertical and internal surfaces of each of the horn openings. Finally, the density of soot deposition inside and outside the alarm horn chamber was evaluated for each of the alarms in which the horn was mounted to the cover of the alarm, thus forming a chamber between the horn opening and the piezoelectric sounder (Fig. 3a). See Figure 5 for a collection of photographs documenting enhanced soot deposition patterns around the horn openings.

Enhanced soot deposition on the external face of the horn opening is a potential indicator of an alarm sounding (Fig. 5a). Another indicator is enhanced deposition on the vertical surfaces of the horn opening into the sounding chamber (Fig. 5b). A third indicator is enhanced deposition on the internal face, which can particularly be characterized by a pattern of increased soot density fanning radially outward from the horn opening (Fig. 5c). Figure 5d shows the enhanced deposition and lack of deposition within the horn chambers relative to the underside of the alarm cover for smoke alarms that sounded and did not sound during the fire, respectively.

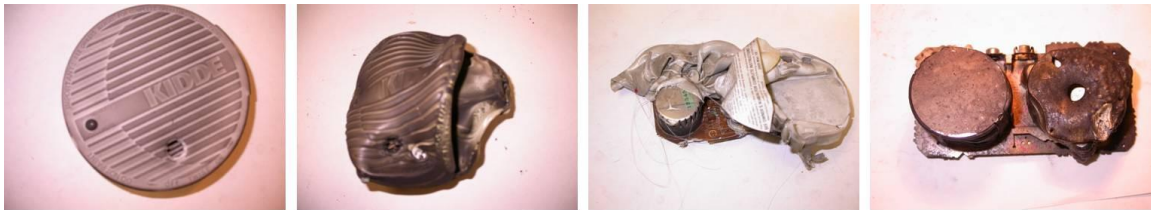
Figure 7: Photographs illustrating the range of post-test alarm conditions evaluated in study.

A total of six fires were set, consisting of three unventilated and three ventilated enclosure fire tests. Of the six enclosure fires, four reached flashover conditions within the room of origin. Consequently, the conditions to which the alarm evaluated in this study were exposed varied significantly. In three of the enclosure fires with accelerant ignition scenarios, the alarms were exposed to rapid fire growth resulting in relatively short duration, severe thermal exposure and sooty conditions. The remaining three fire tests conducted with accidental ignition scenarios resulted in prolonged exposure of the alarms to moderate thermal and smoke conditions. As a result of the different types of fire conditions to which the alarms were exposed, the post-test condition of the alarms varied from severe (i.e., complete melting and detachment from the ceiling) to relatively moderate (i.e., thermally discolored with no evidence of physical deformation). Photographs illustrating the variety of damage to the alarms being evaluated are presented in Figure 7.
